# Section 19 Flood Investigation Report

## Wood Green

### London Borough of Haringey

M01600-13\_DG01 | January 2022

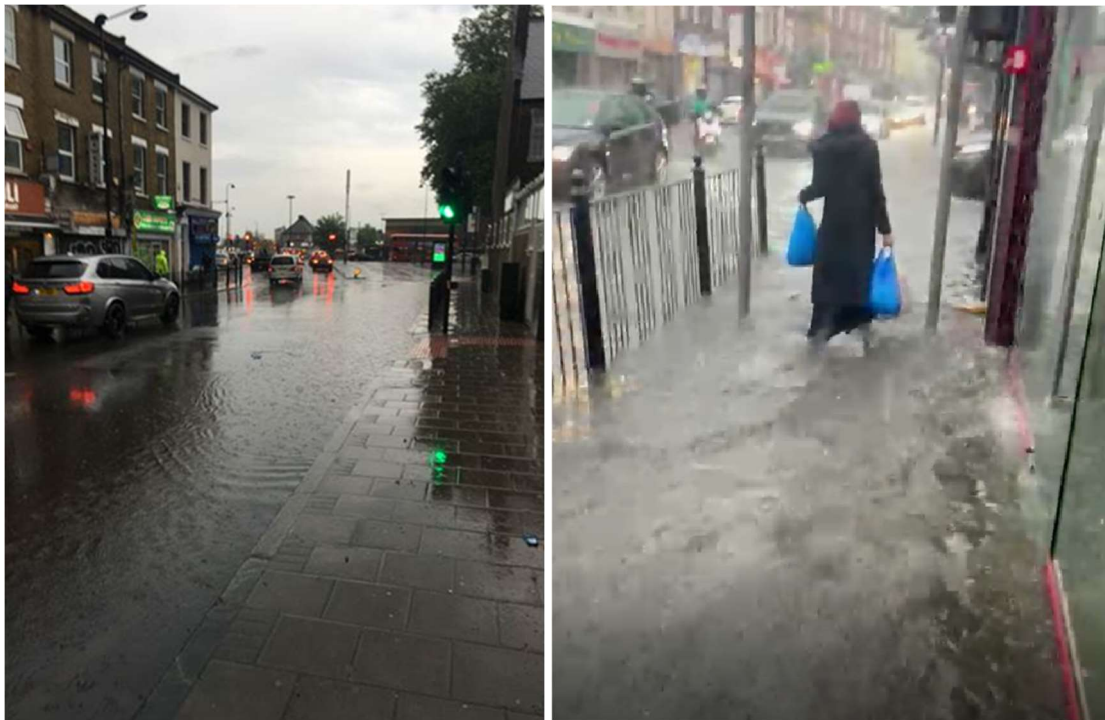
**Figure 5-3 Flooding on Turnpike Lane, 12th July 2021**

Video footage was received of Turnpike Lane near its junction with Willoughby Road at 19:21pm on 12<sup>th</sup> July 2021. The footage shows the carriageway and part of the adjacent footways inundated with water up to up to approximately 400mm deep. Pedestrians are observed ankle deep in water, with one observed attempting to unblock a drain along the main road. Vehicles continue to pass creating bow waves which wash the flood waters further onto the footways. Commentary in the video indicates that the flood water is being washed into adjacent shops. A second video shows the flood waters covering the entire footway outside numbers 6-18 Turnpike Lane. Flood waters can be observed flowing into business premises at No. 16 Turnpike Lane. A social media report from the business owner of No. 1 Turnpike Lane described how flooding occurs from the manhole outside the business premises.

The video and anecdotal evidence strongly suggests that the primary cause of the flooding was excessive rainfall which exceeded the capacity drainage network in this area. The intensity of the rainfall meant that surface water was unable to enter the sewer network fast enough and accumulated in the topographical low points, which reached sufficient depths to enter property. The DWMP model outputs suggest that the limited receiving capacity of the sewers would have been the primary cause of flooding. This is supported by anecdotal evidence from a local business describing water escaping from a manhole on Turnpike Lane<sup>6</sup>. Further investigation would be required in the east of Turnpike Lane to identify whether the capacity issues were primarily due to the receiving capacity of the highway drains, the public sewer or both. It is also understood by Haringey Council that the sewers in this part of Turnpike Lane are relatively shallow; this would need to be confirmed by Thames Water. Other contributing factors to the extent (depth and magnitude) of flooding include:

- **Sewer incapacity**  
Flooding was observed from manhole at No. 1 Turnpike Lane. Haringey Council have indicated that the 9 inch sewer along Turnpike Lane is very shallow with invert of the sewer just lower than the outlet from the gully pots. Haringey have noted via email (20/01/22) that that have been informed that during heavy rainfall, runoff cannot enter the gully pots as the sewer system is already in surcharge status. Potential for a foul connection has been identified by Haringey. Capacity of the storm sewer will be further compromised where there is a foul connection.

- **Bow wave effect**  
Video footage from the 12<sup>th</sup> July flooding along Turnpike Lane indicated that larger vehicles moving through the flood water caused a bow wave effect. Anecdotal reports from local business confirmed that this led to further movement of water onto the footway and into properties.

- Thames Water to investigate presence of foul drainage connection to storm sewer and remove (if connection is identified) to reduce hydraulic load on storm sewer network. Given the observed surcharge status of the sewer and the manhole flooding outside No.1 Turnpike Lane, increase of sewer capacity at this location should be investigated by Thames Water.

- Haringey Council have noted that they will be undertaking increased frequency of gully pot cleaning along Turnpike Lane.
- Haringey Council to consider implementation of SuDS measures in the upslope catchment to reduce the amount of runoff reaching the location of flood risk.
