Section 19 Flood Investigation Report South Tottenham, London Borough of Haringey

M01600-15_DG01 | January 2022

DOCUMENT FILENAME	M01600-15_Dg01 Section 19 Investigation Rev 3
DOCUMENT REFERENCE	M01600-15_DG01
TITLE	Section 19 Flood Investigation Report
CLIENT	Haringey Council
CLIENT CONTACT	Pankit Shah
PROJECT MANAGER	Anthony McCloy
AUTHOR(S)	Andy Hughes
BRANCH	BELFAST Mossley Mill, Lower Ground (West), Carnmoney Road North, Newtownabbey BT36 5QA T: +44 (0) 28 9084 8694 W: <u>www.mccloyconsulting.com</u>

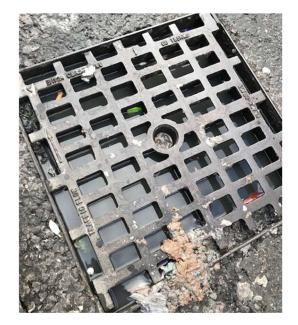
A site walkover on 28th October 2021 showed that at least 2 no. gullies along a 100m stretch of the road were blocked. Any blockages would have reduced the capacity for surface water to enter reach the public sewer.

Figure 5-4 Blocked gully outside 490 High Road, 28th October 2021

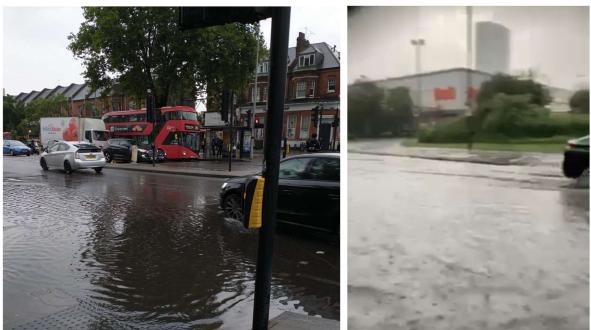
Figure 5-6 Flooding in Broad Lane, South Tottenham, 25th July 2021

In Broad Lane and Markfield Road, the topography, existing sewer and culvert network (and DWMP outputs) and connections to the River Lee suggests that the primary cause of flooding was excessive rainfall which exceeded the capacity of the drainage network in the area. The rise in water levels in the River Lee would have increased surcharging of the sewer and culvert network; this in combination with the intensity of the rainfall meant that it accumulated on the surface, flooding the carriageway.

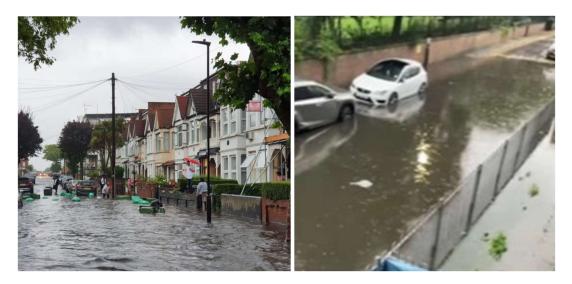
Figure 5-7 Flooding in Elm Park Avenue (L) and Lemsford Close, South Tottenham, 25th July 2021

In Elm Park Avenue and the neighbouring streets, the photographs and DWMP outputs strongly suggest that the primary cause of the flooding was the limited receiving capacity of the sewers. The intensity of the rainfall meant that surface water was unable to enter the sewer network fast enough and accumulated in the topographical low sections of Elm Park Avenue, Clifton Gardens, Grovelands Road and Lemsford Close.

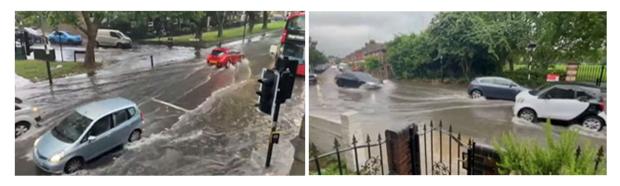
Figure 5-9 Flooding on Seven Sisters Road (L) and Black Boy Road, 25th July 2021

The photographs, flood reports and DWMP output strongly suggest that the primary cause of the flooding was an exceedance of the capacity of the drainage network and culverts in this area, caused by the excessive rainfall which fell on the day. The intensity of the rainfall meant that surface water was unable to enter the sewers and culverted watercourses fast enough and accumulated in the topographical low points, flooding the highways and adjacent properties. The DWMP model outputs suggest that the limited receiving capacity

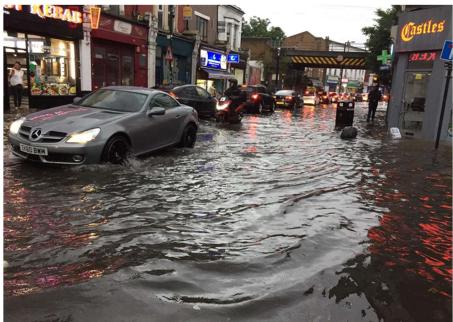
Figure 5-11 Flooding on West Green Road, 25th July 2021

The photos and site evidence strongly suggest that the primary cause of the flooding was exceedance of the capacity of the surface water sewers in West Green Road. Surface water was unable to enter the sewer network fast enough and accumulated in the low-lying area along West Green Road, which reached sufficient depths to flood the highway and enter property. The DWMP model outputs suggest that the limited receiving capacity of the sewers would have been the primary cause of flooding. Observations during the site walkover support this; frequent gully positions were identified at the low spot of the railway underpass (14 no. across 12m of carriageway) but flooding was not prevented. Further investigation would be required throughout this low lying section of West Green Road to identify whether the capacity issues were entirely due to the receiving capacity of the public sewer or whether the capacity of the highway drains was a contributing factors to the extent (depth and magnitude) of flooding include:

The photographs from the flooding along West Green Road shows vehicles moving through the flood water, which in other instances across Haringey during the July floods, have caused a bow wave effect. This could have led to further movement of water onto the footway and into properties.

- Haringey Council to consider localised temporary road closures or diversions in high-risk areas with low profile kerbs to reduce ingress of floodwaters onto footways and into properties where risk of internal flooding is caused by bow wave affect from the movement of vehicles through flood waters.

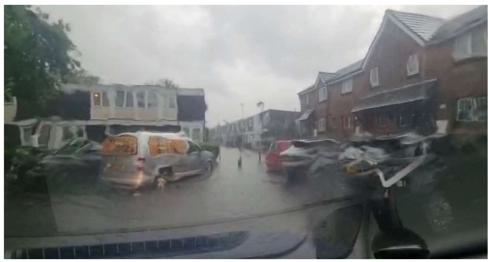
Figure 5-15 Flooding on Milton Road Estate, 25th July 2021

The photos, anecdotal evidence and output from the DWMP strongly suggest that the primary cause of the flooding was excessive rainfall which exceeded the capacity drainage network in this area. The intensity of the rainfall meant that surface water was unable to enter the sewer network fast enough and accumulated in the topographical low points, which flooded highways and properties. Further investigation would be required in the east of Langham Road to identify whether the capacity issues were primarily due to the receiving capacity of the highway drains, the public sewer or both.

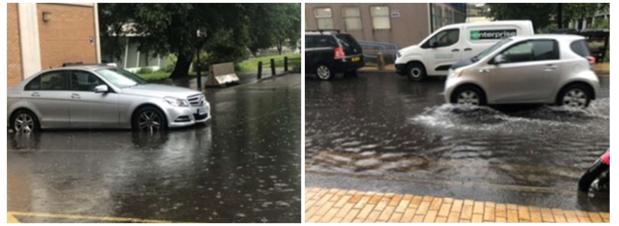
Figure 5-17 Flooding at Broadwater Farm, 25th July 2021

The photos, topography and location of the watercourses suggests that the primary cause of the flooding was excessive rainfall which exceeded the capacity of the drainage network and/or culverted watercourse in this area. The intensity of the rainfall meant that surface water was unable to enter the sewers or culverts fast enough, resulting in an accumulation of water in the topographical low points, which reached sufficient depths to flood the carriageway and enter property. The DWMP model output suggests that the limited receiving capacity of the sewers on would have been the primary cause of flooding on Willan Road. Further investigation would be required to identify whether the capacity issues were primarily due to the receiving capacity of the highway drains, the public sewer, the culvert or a combination.

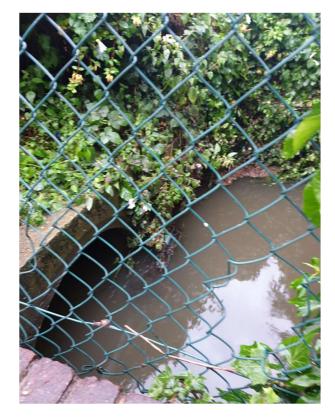
Haringey Council received reports of flooding in the highway at Larkspur Close on 12th July. Haringey Council visited the area at 21:00pm, by which time the flooding had largely receded. It was confirmed to Haringey Council that the floodwaters reached kerb level. The rain stopped before property was flooded but residents had placed sandbags at their front doors in preparation. Responders from Haringey Council noted from their visit a build-up of vegetation at the culvert inlet of the Lesser Moselle watercourse.

Figure 5-19 Moselle Culvert at Larkspur Close, 12th July 2021

Haringey Council visited the area on the evening of 12th July and noted heavy vegetation at the inlet of the Lesser Moselle Culvert inlet. Haringey Council has stated via email that at times of heavy rain debris from upstream reduces the capacity of the culvert inlet.

• It is noted that Haringey Council is progressing a flood resilience / protection scheme at Larkspur Close which will comprise installation of rain gardens within existing green spaces within the Close, installation of a flood retention basin within the green space located at the junction of Fryatt Road and Jellicoe Road, installation of a demountable flood gate at the entry to Larkspur Close and installation of non-return valves at the gully outlet points from Larkspur Close to Moselle Brook along with other ancillary works. The scheme is currently at design stage and no defined date for installation has been provided.
