Advisory & Consultative Committee Meeting on 8th November 2011

<p>Report Title: External Fabric Condition Update 2011-12</p>
<p>Report of Mark Neale Facilities Manager, Alexandra Palace & Park Charitable Trust</p>
<p>1. Purpose</p> <p>1.1 To update the Consultative Committee on the work that has taken place over the last twelve months and those planned in the future on the external fabric of Alexandra Palace.</p>
<p>2. Recommendations</p> <p>2.1 The Consultative Committee is asked to note the progress report on the external fabric condition and the action being taken to address the high priority items.</p>
<p>Report Authorised by: Duncan Wilson, Chief Executive.

Appendix 2: Examples of the Current Conditions followed with Photographs

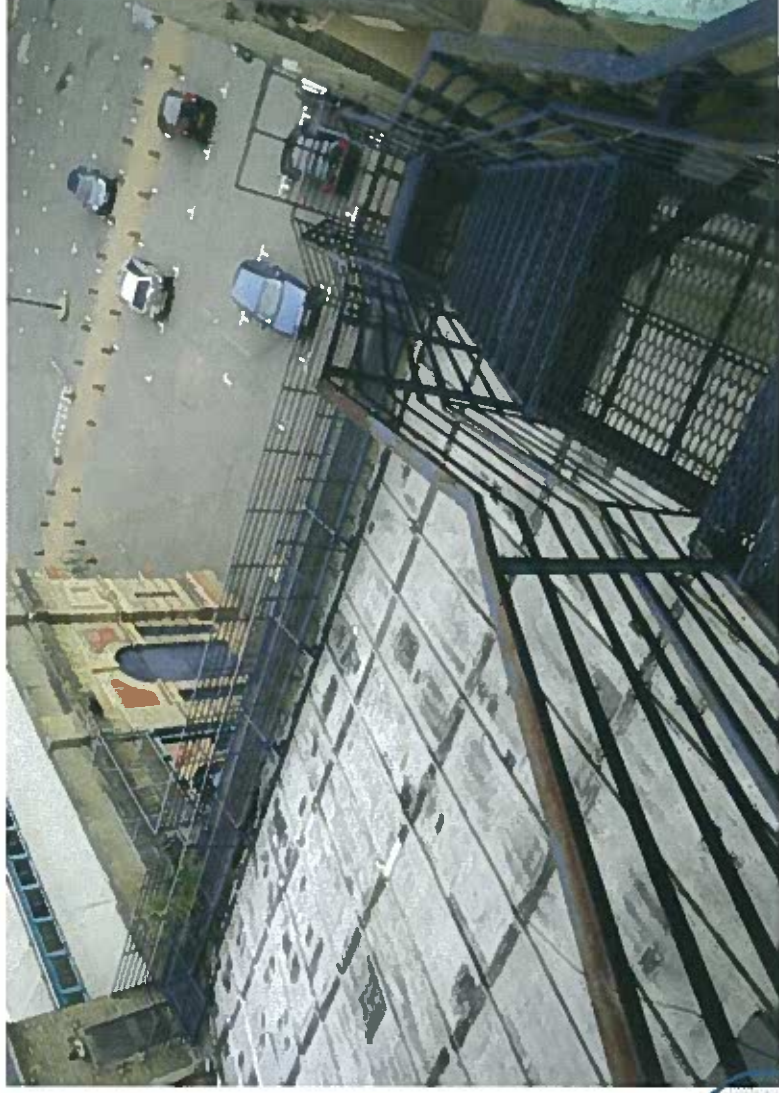
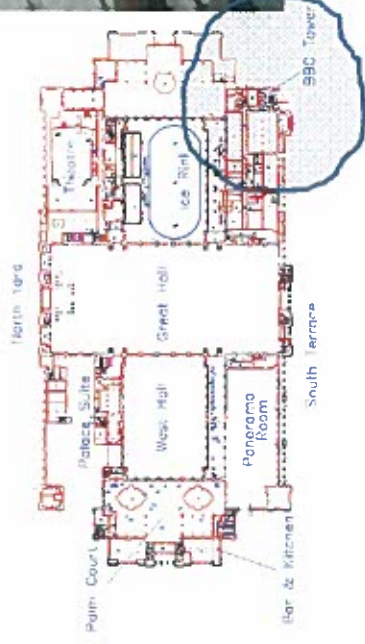
BBC Level 4 & 5 Fire Escape

Design and construction Issues of Fire Escape in this area

- Strengthening of the BBC 4th & 5th floor Fire Escape.
- Roof leaks above Dance Studios.
- Replacement of the concrete and wooden slabs along the front of the South Terrace owing to their poor condition.

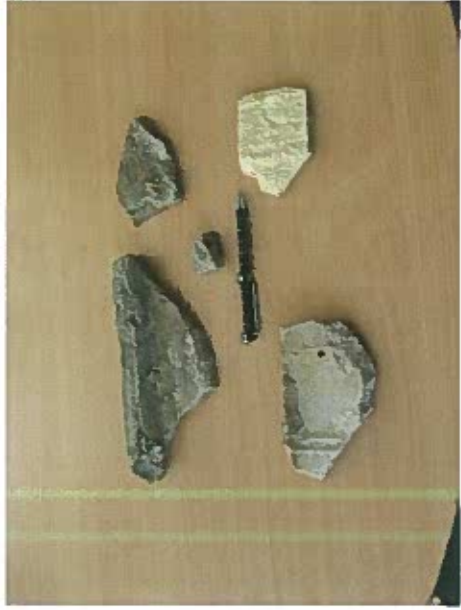
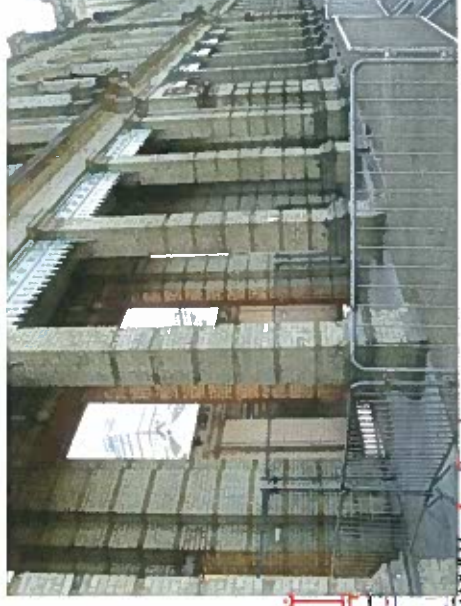
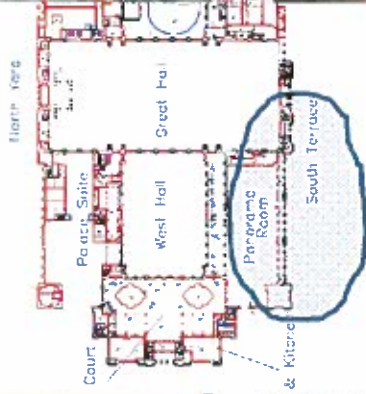
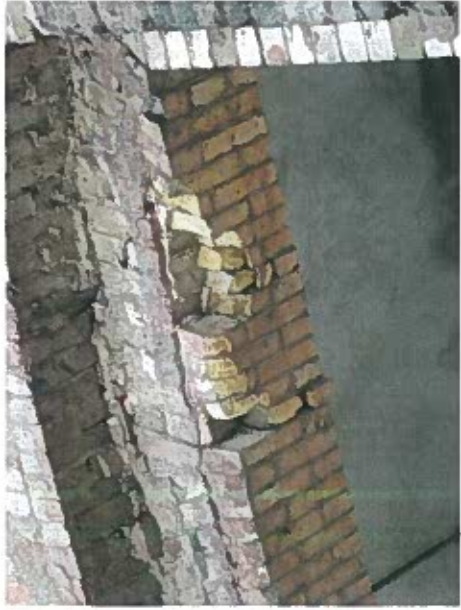
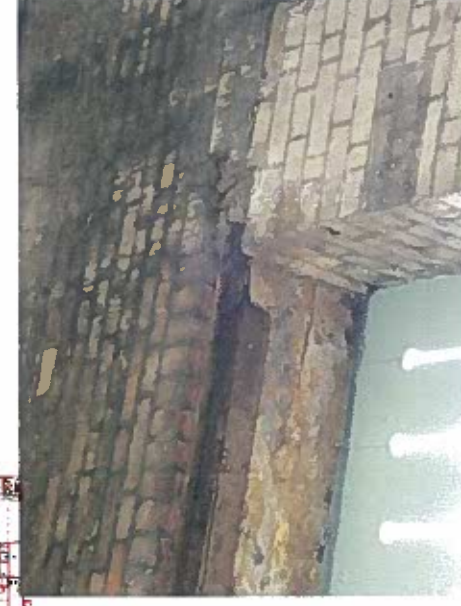
- 6.2 After these works had been completed the barriers were removed from along the South terrace, but within days of this taking place significant falls of masonry took place forcing the barriers to be reinstated. The Structural Engineer has since advised that many of the areas which have concrete render suffer from poor adhesion to the structure. Consequently even areas which appear sound must be considered "Live" and could fail.

- Netting of the South Terrace where further falls of masonry have taken place.
- Repair to two collapsed roof areas near the Ice Rink foyer.
- Fencing of the unstable parapet wall areas at the Rear of Theatre Foyer.

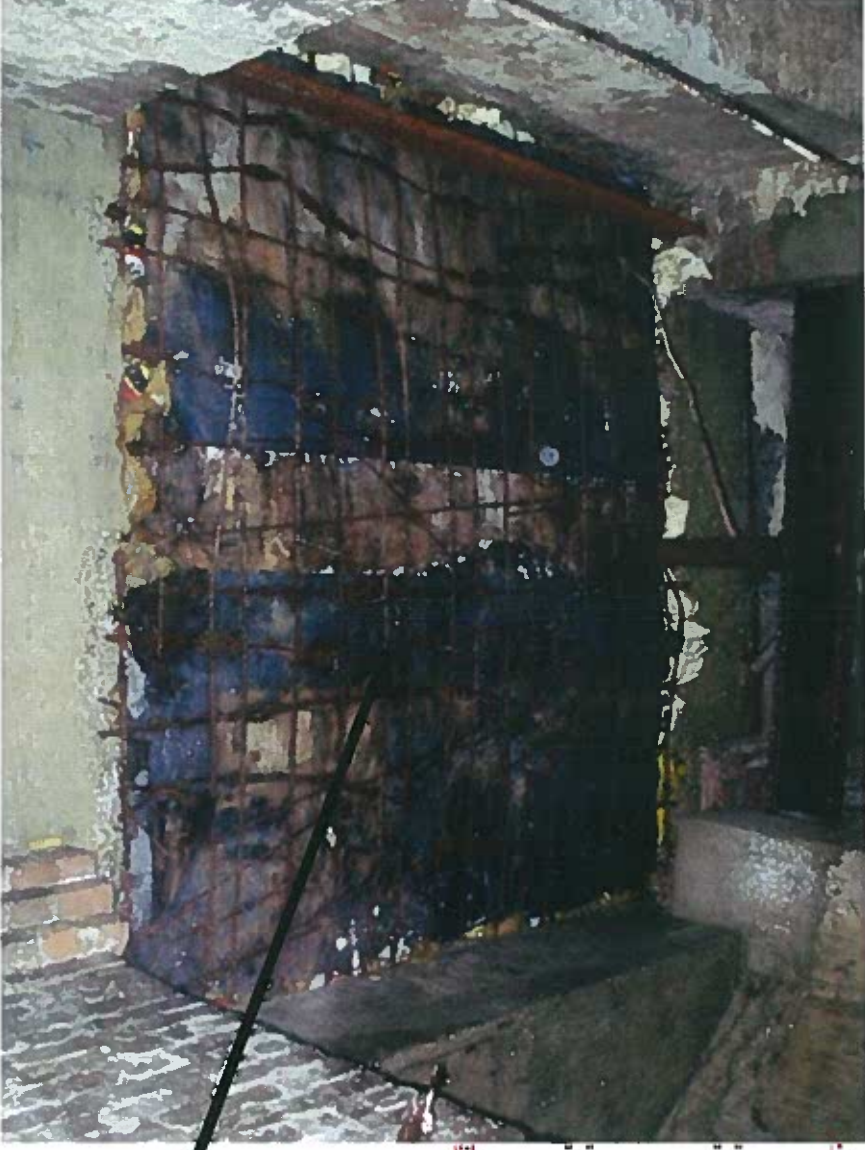
Underground Structure

Two Poor Slab Areas
Front Panorama Room

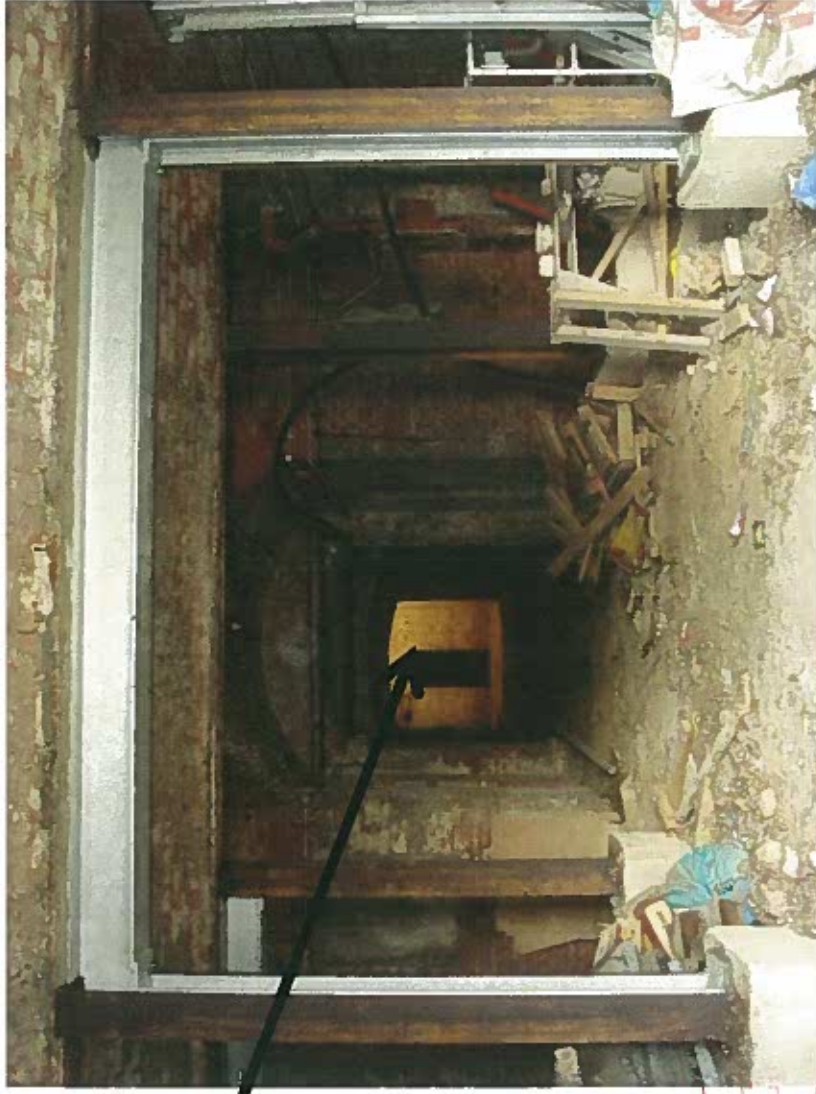
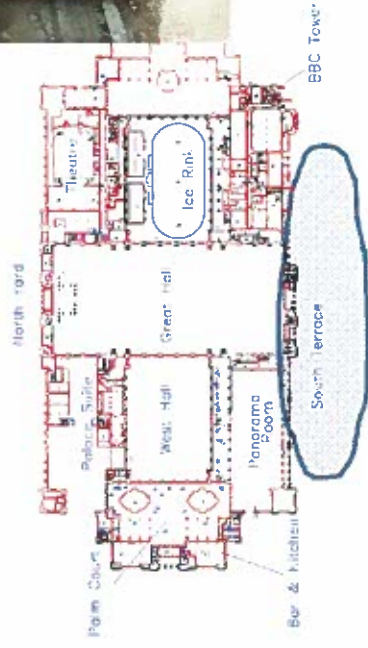
Structural Failures

Structural steelwork failures in several areas under terrace. 3.5 Ton load restriction in place

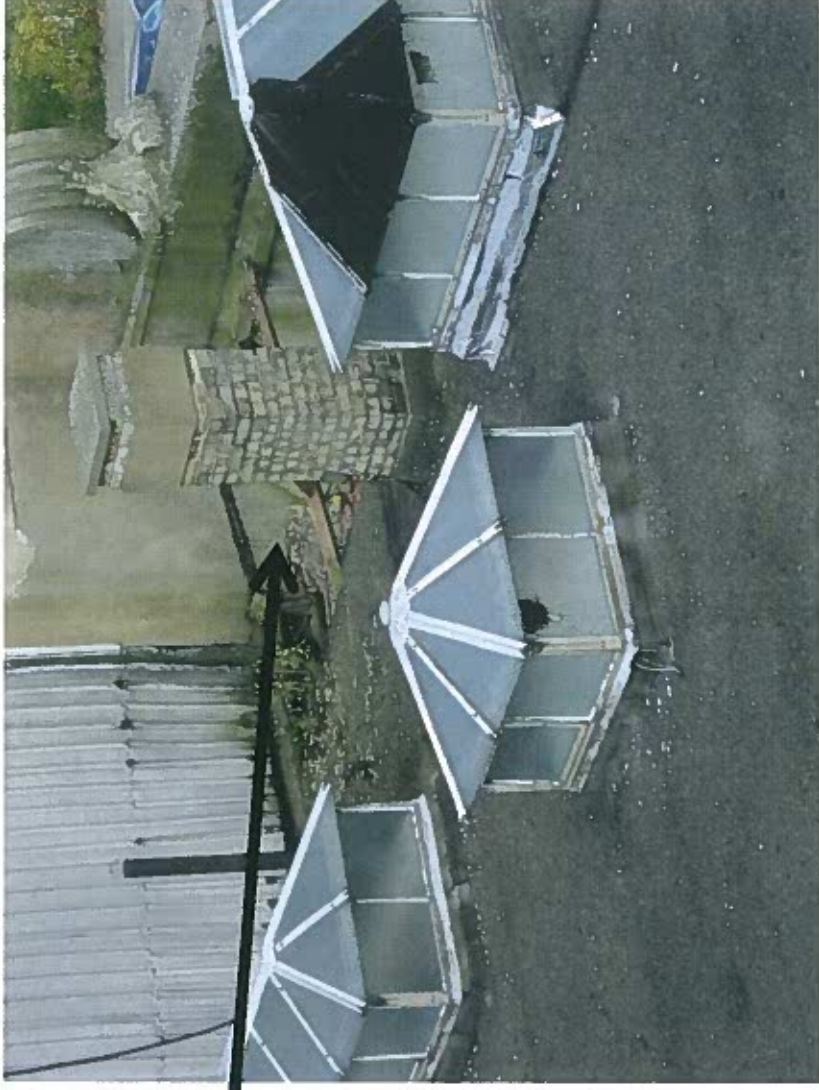
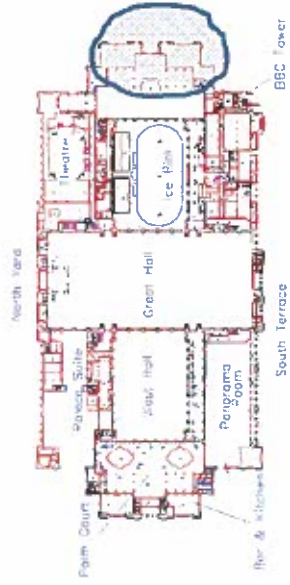
Roof Leaks (Ice Rink Area)

Collapsed Roof
both sides of
Foyer

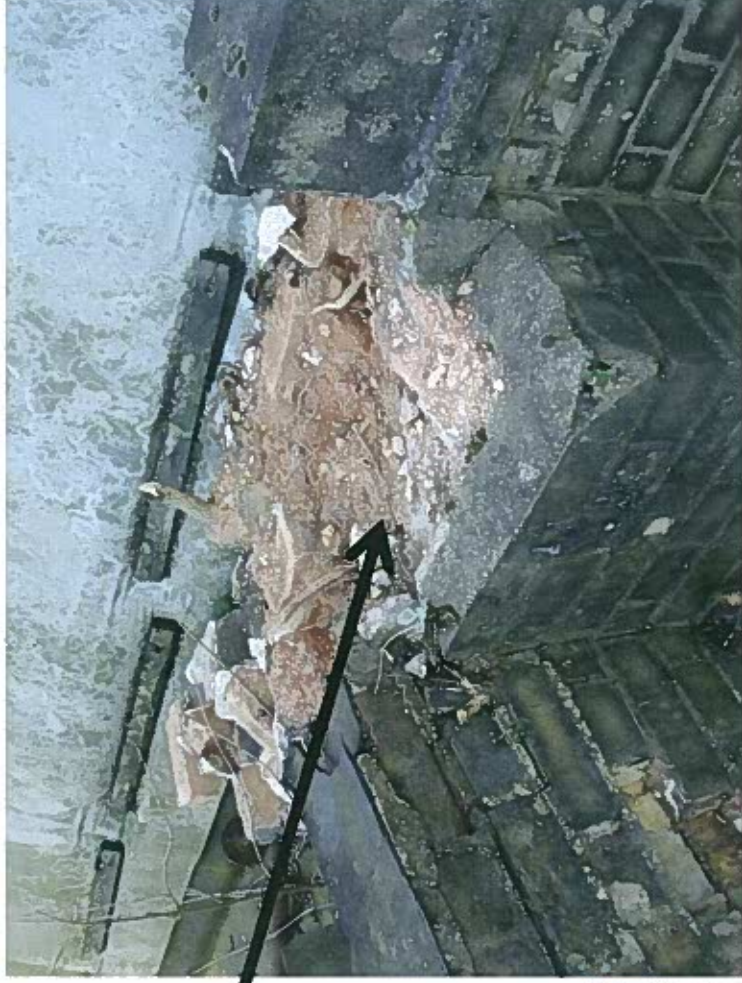
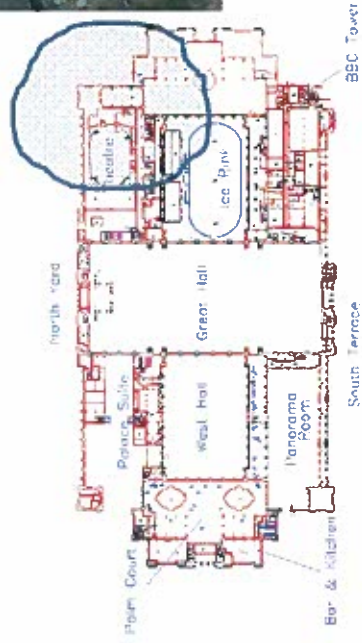
Unstable Parapet Walls

Shrub growth on building allowed to penetrate brickwork

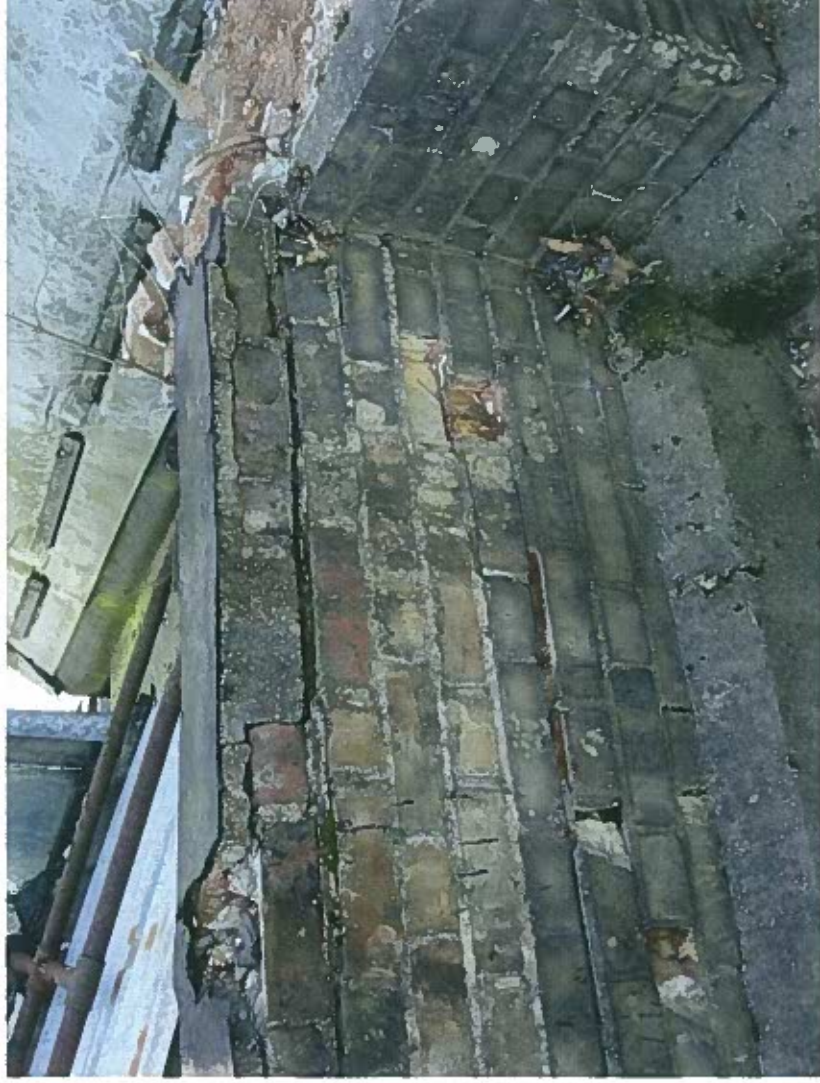
Unstable Parapet Walls

Further examples
of unstable
brickworks
