WOOD GREEN DRINKING FOUNTAIN

HIGH ROAD

LONDON N22

Condition survey and conservation assessment

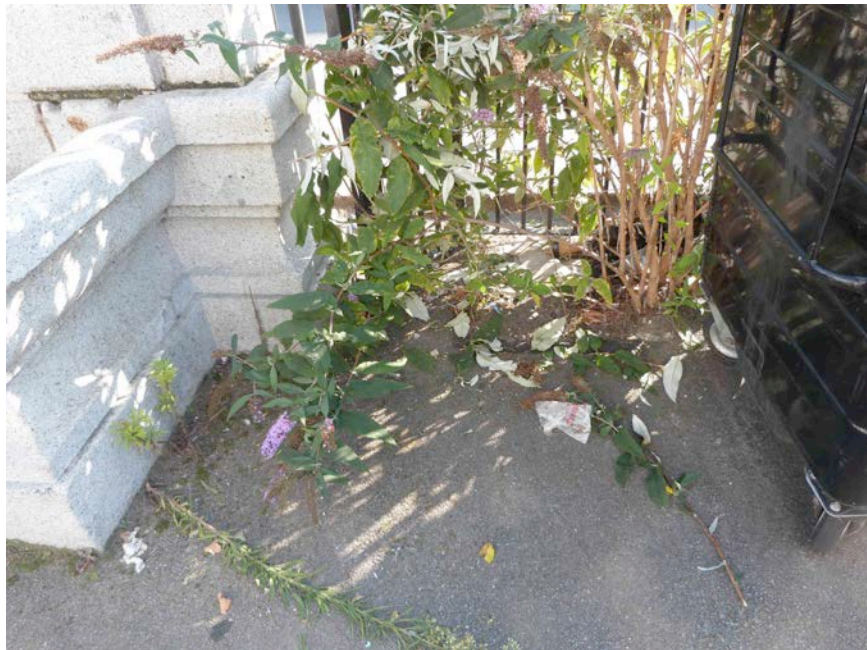
Moss and lichen accumulated at the bottom of the granite base suggest that water sits against the stone during wet weather. The surrounding tarmac is in good condition. There is a manhole to the south side (presumably containing the water supply for the fountain); growing from the side of this is a large buddleia bush.

Fig 7: manhole to the south of the fountain (obscured by Buddleia bush) where water supply is accessed

- Cut back and remove all root systems of *Buddleia* adjacent to manhole on south end of fountain.
- Consider removing tarmacadam surface from around fountain and replacing with more porous surface (for example resin bound gravel) that helps water to drain away from around the structure. This would also provide a distinct surrounding for the fountain that would separate it from the more prosaic surroundings.
- Allow to install drain from area between current pavement and east elevation of fountain to prevent water accumulating in that space.

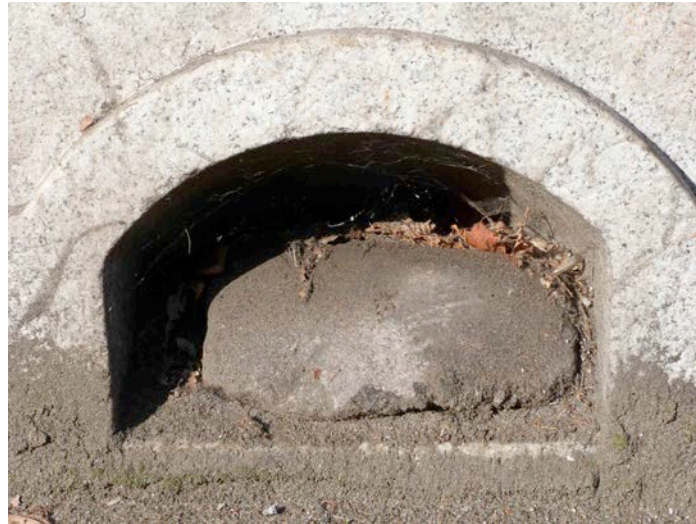
The base (course A) is in excellent condition with almost no signs of damage or decay. The lower sections are dirty with accumulated biological growth. The recess for the dg drinking bowl (Fig 8) at ground level on the east side has been filled with tarmac and other assorted debris; it was impossible therefore to

inspect the condition of the bowl itself. The small strip between the base and the pavement on the east side is set lower than the pavement and it is thought that there is standing water during periods of heavy rainfall. In general the ground level around the base is probably higher than it was originally.

Fig 8: recess for dog bowl filed with tarmac and debris

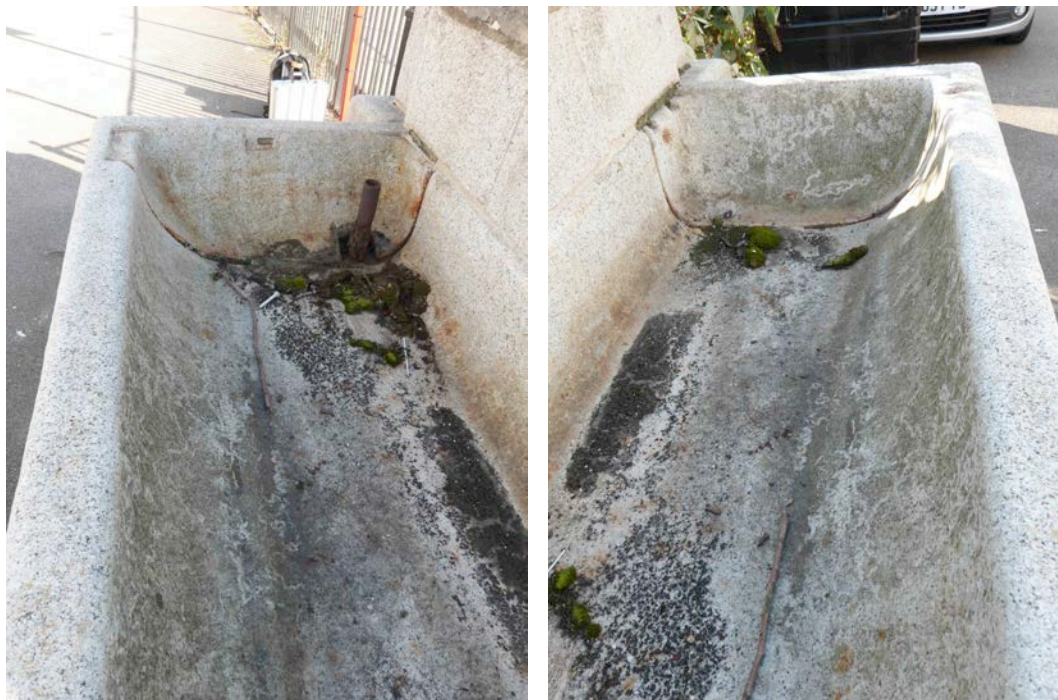
The main trough on the west side has a number of rebates cut into the top rim (one at north end, one at SW corner and two at the SE corner); the purpose of these is unknown but it is thought that they were the location for various element of the plumbing or water disposal. There are grooves cut across the trough at either end which look as though they were plates were set into the stone. In the SE corner at bottom of the trough, there is the remnants of a lead pipe which was either a drain or it could equally have been for the supply of water.

Figs 9 and 10: view of interior of main trough from the south and north

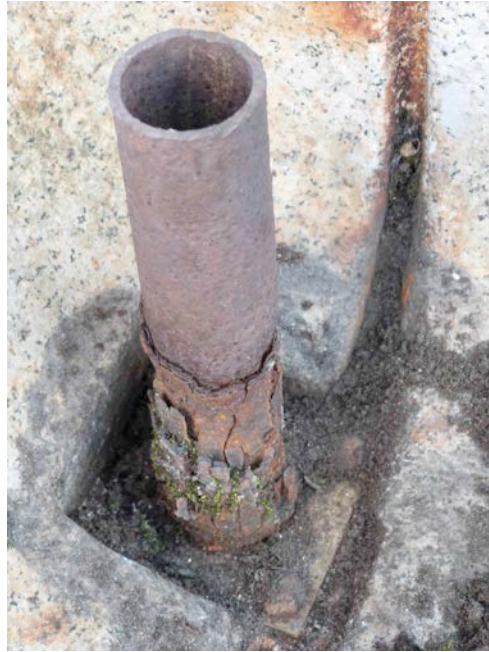
At the NE corner, there is an upstanding iron pipe (Fig 11) (about 50mm in diameter and about 200mm high). A flange plate at the base of the pipe is bolted to the granite; this arrangement is thought to be an overflow system for the trough. The pipe itself is corroded and not thought to be original; there is no associated damage to the granite.

Fig 11: corroded pipe and flange plate

- Remove rusted overflow pipe and check that hole beneath drains away to prevent accumulation of water within trough.
- Clear out basin on east side and ensure that drain is working well to prevent accumulation of water within basin.
- Install small plates over holes in panel above basin. These might be designed so as to help with the interpretation and also allow use of the holes in the future should decisions be made to install the plumbing.

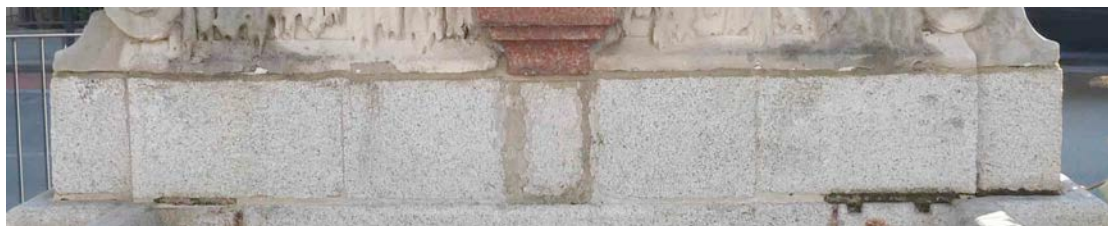
The granite blocks of course B are all sound; most of the horizontal joints have been repointed in cement mortar. In particular the joints around the central block on the west side have been crudely repointed (Fig 12). This block is thin and was probably designed to be removed to provide access to the plumbing mechanism of the drinking fountain at the same height on the east side. There are old fixing holes at the south end that have been filled.

Fig 12: course B on west side of fountain

- Rake out pointing to course B to a minimum depth of 20mm and replace with hydraulic lime mortar left recessed behind face. Mortar should be designed to be more visually sympathetic to the granite.
- Rake out horizontal joints on stones of course C
- Allow to consolidate decayed detail especially at ends of decorative 'drips' on carvings of west and east elevation
- Allow for mortar repairs to protect decayed areas of stone
- Rake out and repoint joints around granite panels
- Remove all resin repairs
- Allow to indent 4 No sections of moulded cornice (each stone not exceeding 150 x 75 x 100mm)
- Rake out and repoint joints between main stone and applied stone arch (east elevation)
- Rake out and repoint joint in stone adjacent to Boar's head keystone

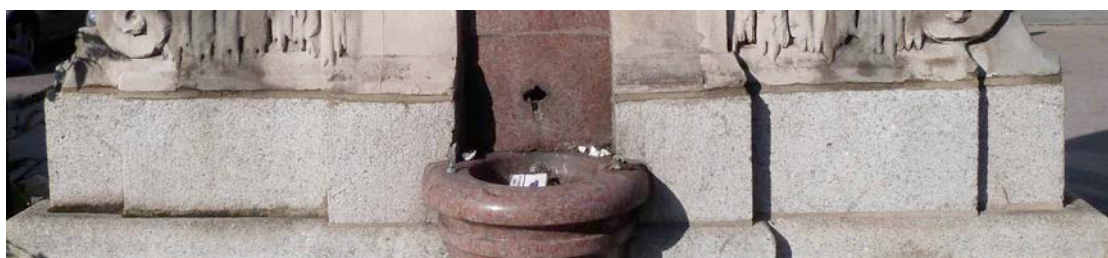
Fig 13: course B on east side of fountain

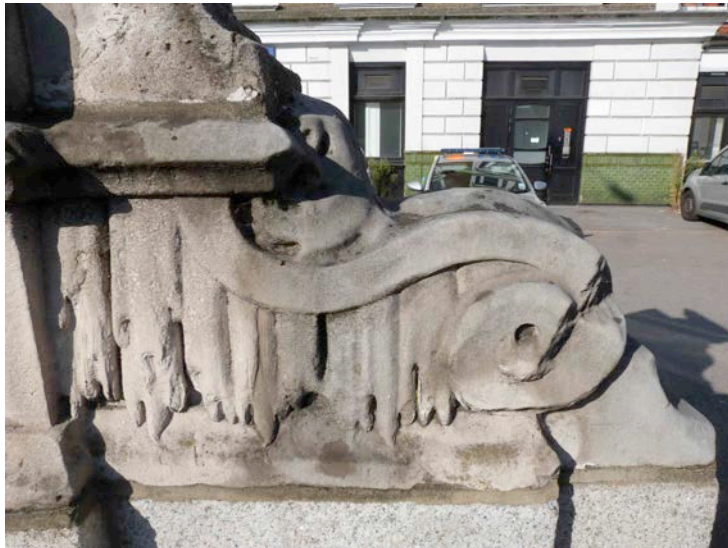
The decorative bracket stones (course C) are generally sound but much of the detail has softened through erosion. There is some accumulation of moss on the upper surfaces and a general grey colour on the stone over most areas; this is due to microbiological growth within the pores of the stone rather than the accumulation of dirt. There are some areas of localised decay and damage; for example on the corners and edge of the scroll.

Fig 14: east side of north stone of course C

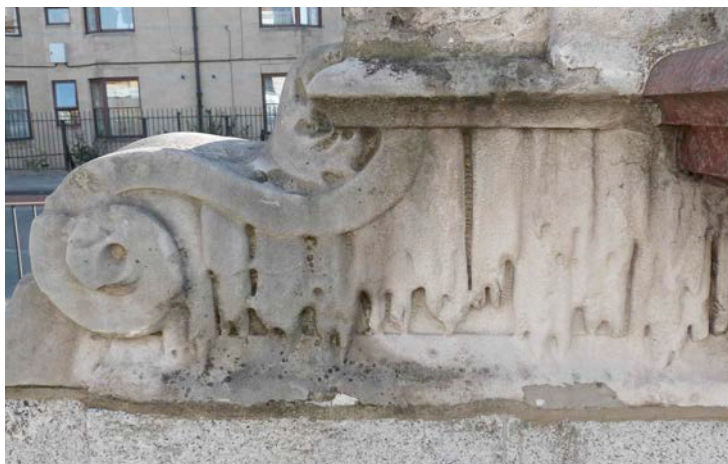
Fig 15: west side of north stone of course C

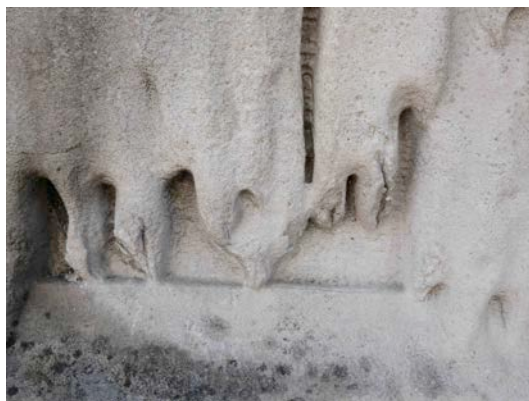
Fig 16: example of decay to Portland stone detail

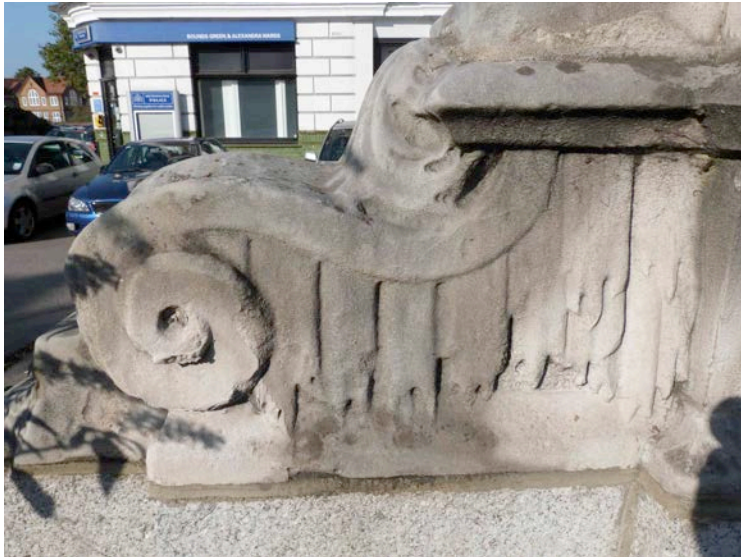
Fig 17: east side of south stone of course C

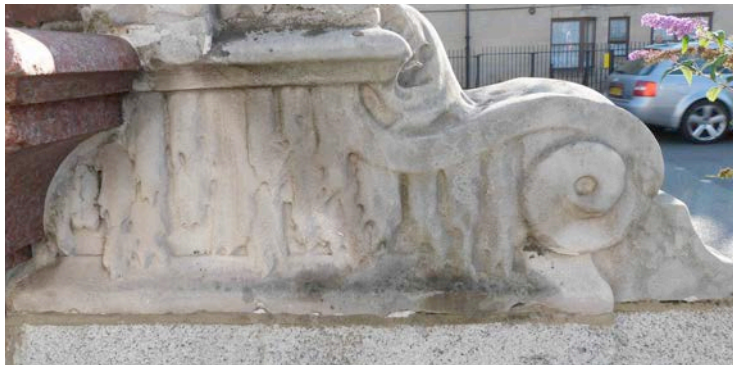
Fig 18: west side of south stone of course C

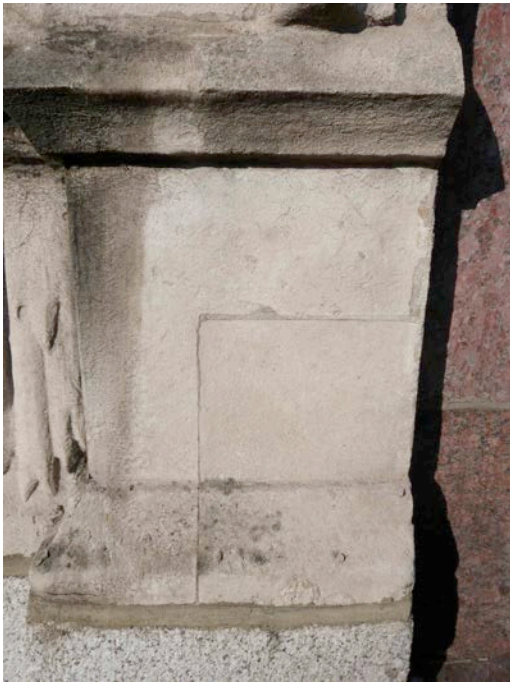
Either side of the central arch on the east side, there is a square block of repair. On the south side, this repair consists of a stone indent (Fig 21); on the north side, it is a well-executed cement mortar repair (Fig 22). The symmetry of these repairs suggests that there may have been some fixings that had caused damage to the stone. The cornice above these areas is also made up in a cementitious mortar that is generally a good match for the stone and is not causing damage. There are other small areas of repair on the same cornice on the west side; again, these are all intact.

Fig 21: stone indent on south side of basin

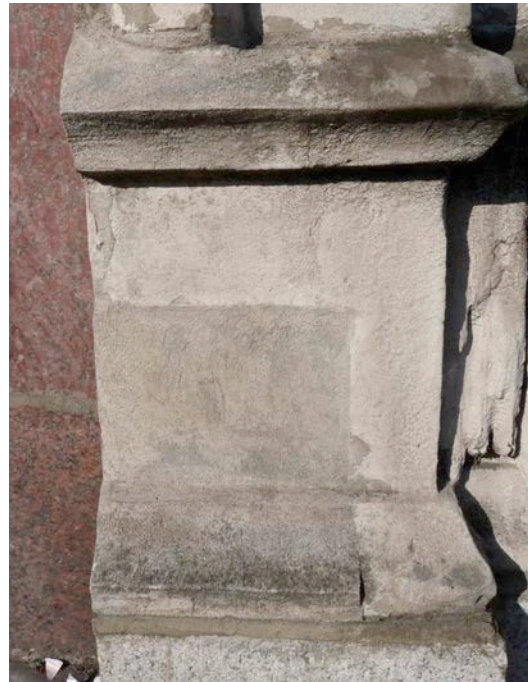
Fig 22: mortar repair on north side of basin

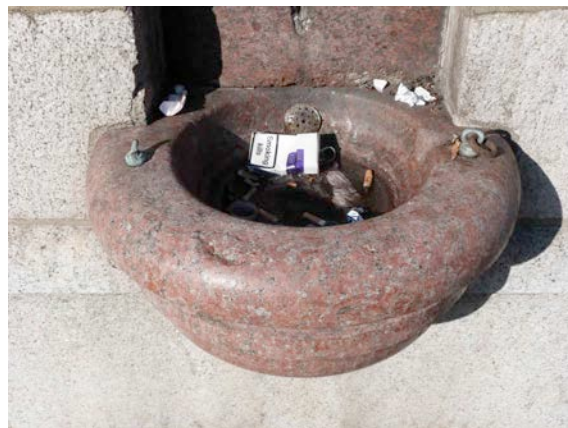
The granite bowl of the drinking fountain is in good condition. There is minor damage to one area of the top of the rim. The bronze fixing on the south side is broken; the one on the north side is intact and has one link of a chain attached. The drain is intact but seems to be blocked as there was some standing water (along with various other rubbish and debris) in the bowl.

Fig 23: Central basin on east side with debris, drain and cup hooks

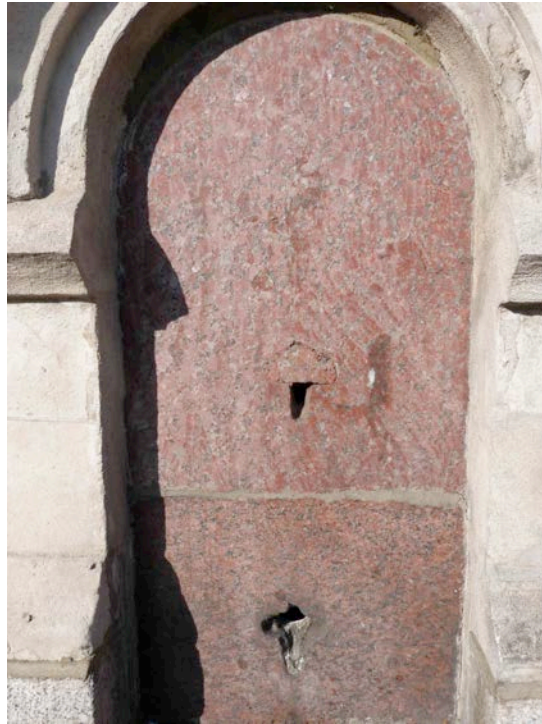
The granite panel above has some historic damage/deterioration adjacent to the joint with the bowl; the hole in the centre of the panel has some remnants of mastic and mortar. This panel appears to be slightly set back from the original plane and it tilts towards the south. The upper panel is in sound condition; it may not be original as it is of a slightly different type of granite and it appears to have been re-set with a large cement joint running around the top. There is a small indent above the hole in the middle of the panel.

Fig 24: granite panel above basin on east elevation

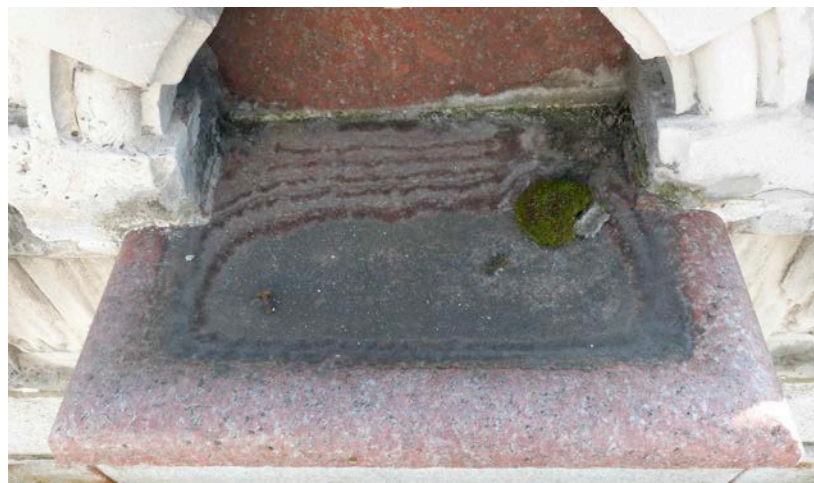
The granite bowl on the west side (Fig 25) and the associated panel within the arch are in good condition with some staining at the intersection of the two. The retention of water within the basin is showed by the tide marks and staining on the inside of the shallow bowl.

Fig 25: upper granite basin on west elevation

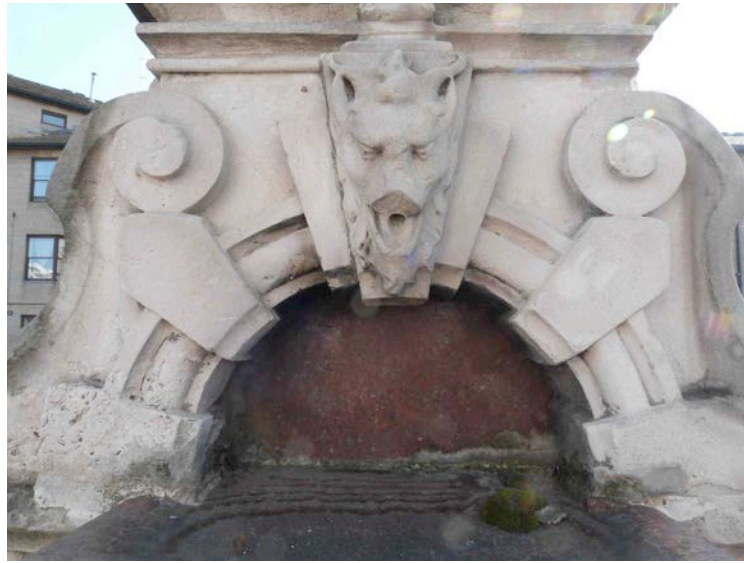
The southern scrolled arch stone (Fig 26) (course D) is in fair condition but the detail is generally softened and it has an overall grey appearance due to microbiological growth in the surface. The cornice on the east side has decayed with one small section indented with new stone and other sections repaired with resin. The west elevation generally has sharper detail and the cornice has areas of mortar repair built up on an iron armature (see covermeter survey). The underside of the arch has significant sulphation (up to 10mm depth). The nose of the boar's head has broken off (possibly due to vandalism or removal of the pipe that used to be set within the mouth). There is some active decay to the mini scroll above the head.

Fig 26: arch on west elevation

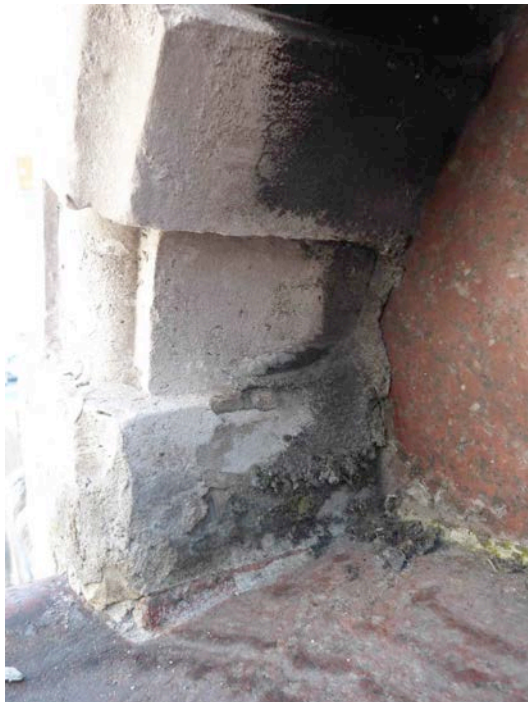
Fig 27: interior of arch (north) showing sulphation

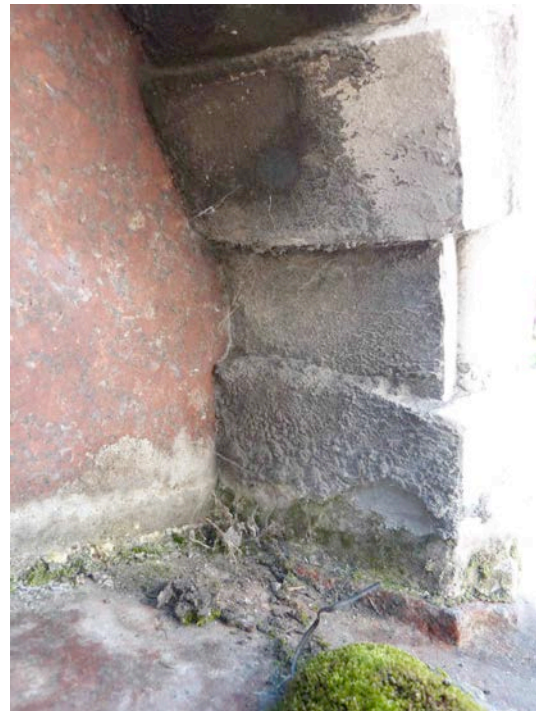
Fig 28: interior of arch (south) with sulphation

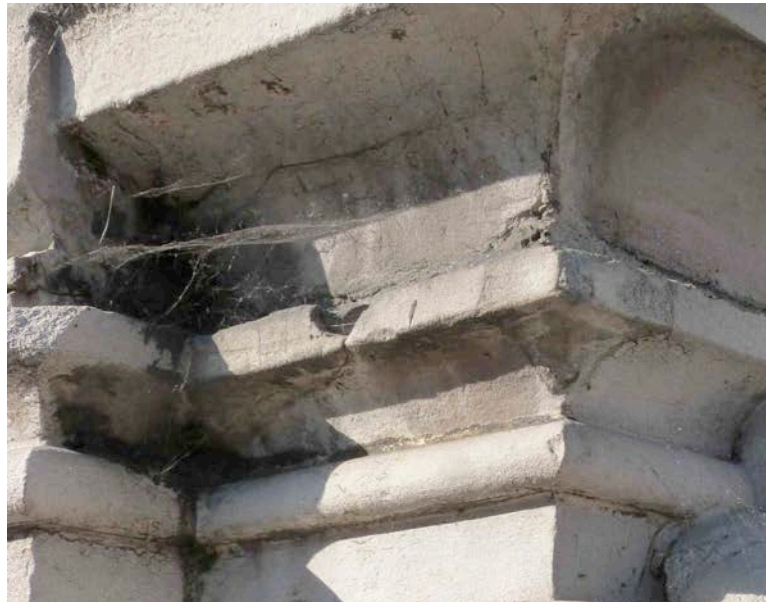
The northern scrolled arch stone (course D) has a much shellier texture and there is some disruption to the surface as a result of that. It generally has a grey appearance (due to microbiological growth) but the harder stone has meant that detail is better preserved. There are some repairs to the cornice on the east side and the cornice on the west side is extensively made up with mortar supported on a ferrous armature (see covermeter survey).

Fig 29: cornice made up with mortar on armature

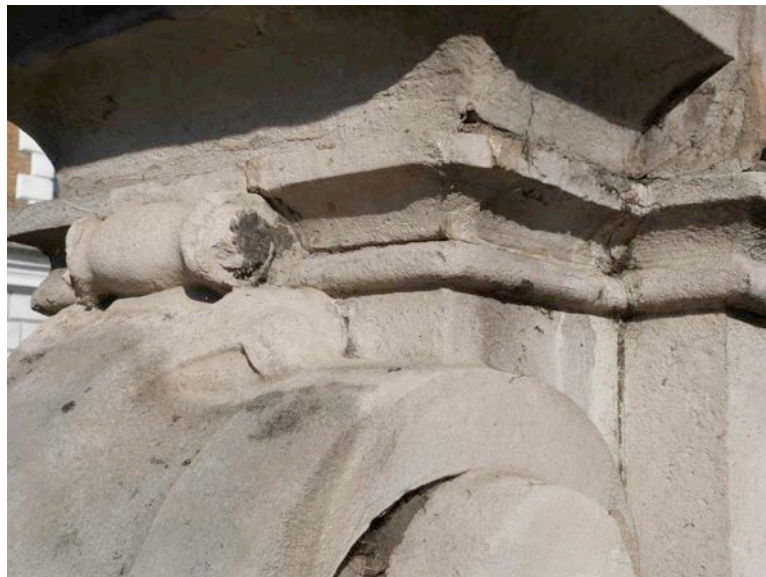
Fig 30: cracks and repair to applied section of cornice on east elevation

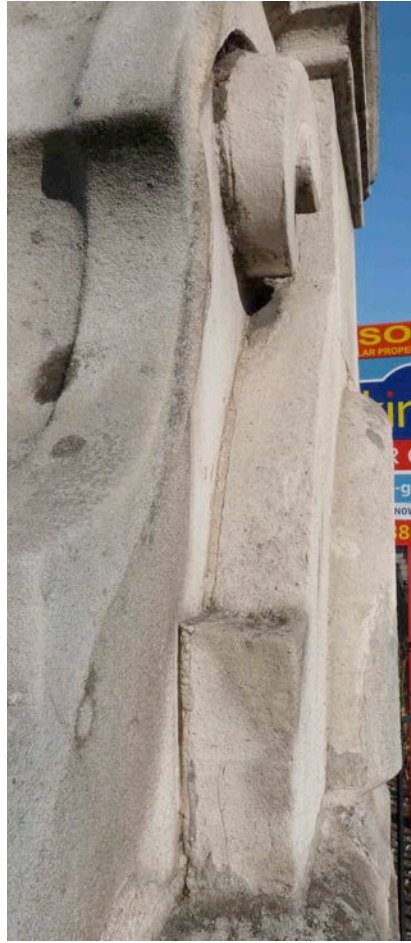
The applied stones (maximum 50mm deep) on the east elevation are sound. There is a crack through the top of the arch that has previously been filled. There is also a cementitious repair to the top surface of the arch. The ashlar panels and cornice above are sound although there are cracks in the vertical joints between these stones and the host stone (Fig 31).

Fig 31: detail showing vertical joints between main stone and applied sections of arch on east elevation

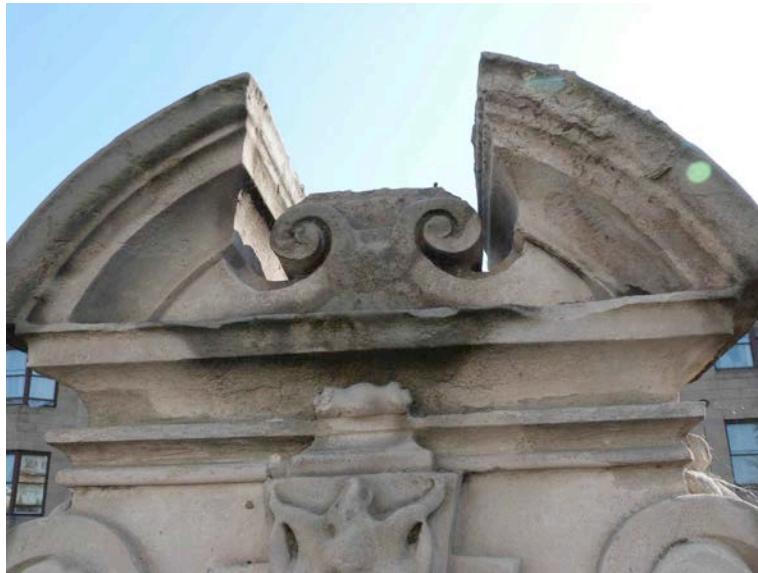
The top stone (course E) is in fair condition. The stone is shelly in texture, particularly on the south end. The detail is generally worn; this is particularly evident on vulnerable edges of the cornice and at the ends of the southern pediment. The lack of detail on the cornice has caused uneven run-off of water that has led to the grey patch on the west elevation. The east elevation is better with only minor deterioration and repair to the arrises.

Fig 34: west side of pediment stone showing grey staining to stone

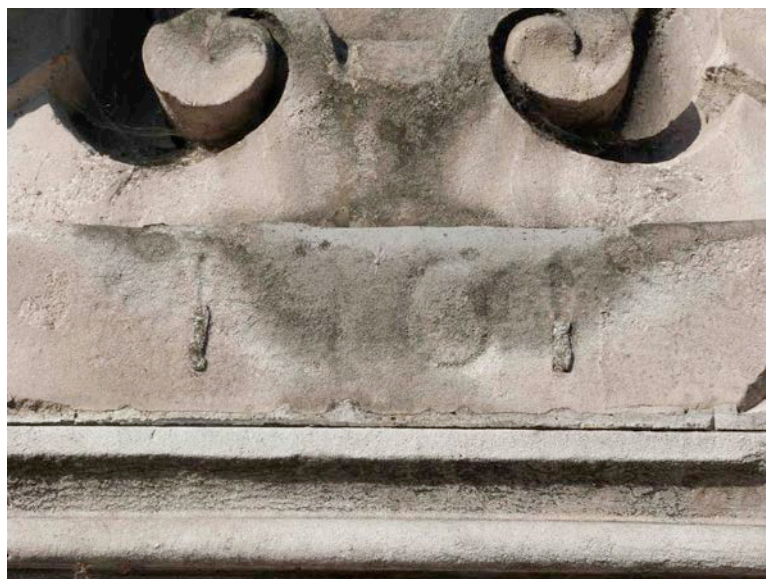
On the east side, there is the remnants of an inscription that reads 1901 although the legibility is severely compromised. There are the remains of mortar that suggest that the inscription was applied rather than incised. The horizontal joint on the east side is open and decayed. The plinth at the centre of the broken pediment has one pin sticking out of the top and a corresponding recess on the other side. Between the two is a pentagonal hole that goes down into the void where all the water mechanism was hidden. This may have held some sort of light.

Fig 35: detail of east side of pediment with remains of inscription

- Allow to indent small section of carved stone to Boar's nose using archive photo if available.
- Using hydraulic lime mortar, fill voids in shelly stones
- Allow to insert new capping stone to pediment plinth; this should be the same size as the existing plinth in plan and stand maximum 60mm high. Allow to cut rebate for retained fixing.
- Allow to make up new cast bronze numbers to re-introduce the date '1901'

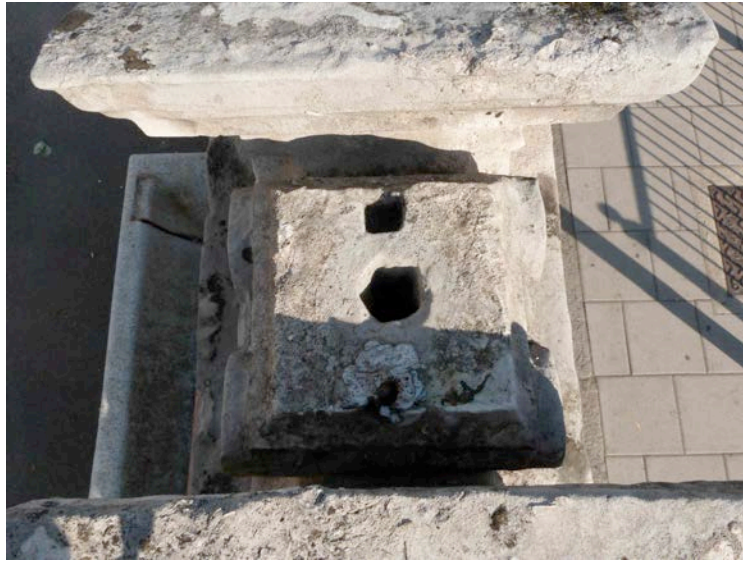
Fig 36: top of plinth of pediment showing old fixings and holes that may have been associated with lighting

In considering options for the first of these, it is not possible to make a proper judgment, as it is not known what the original design was. It may be that there is archive material available which could shed light on this but, in the absence of any evidence, the only option is to mitigate any further deterioration. This would best be accomplished by protection the holes on the sky-facing surface of the plinth by inserting a small stone cap over the holes; this would also help to protect the remaining fixing.
