Appendix 1

Descriptions of Properties

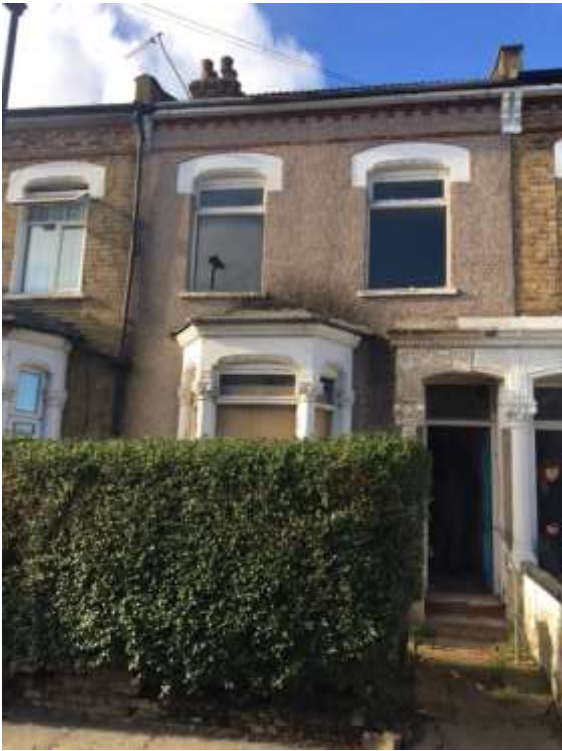
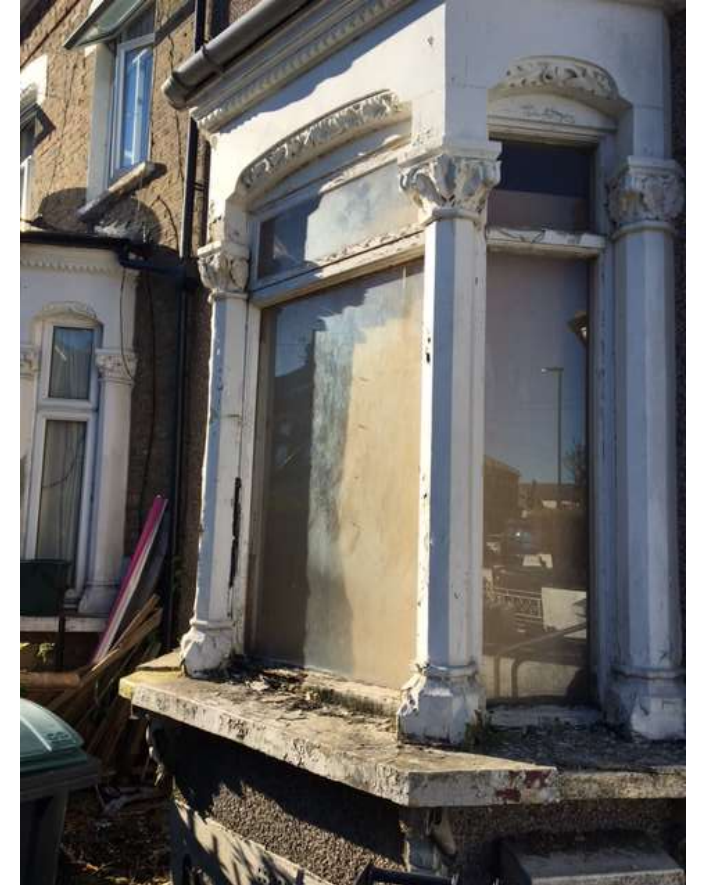
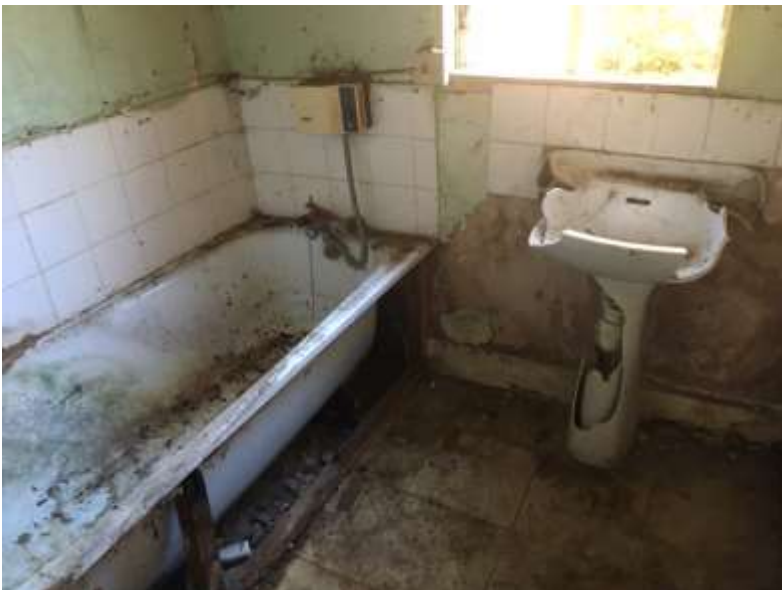
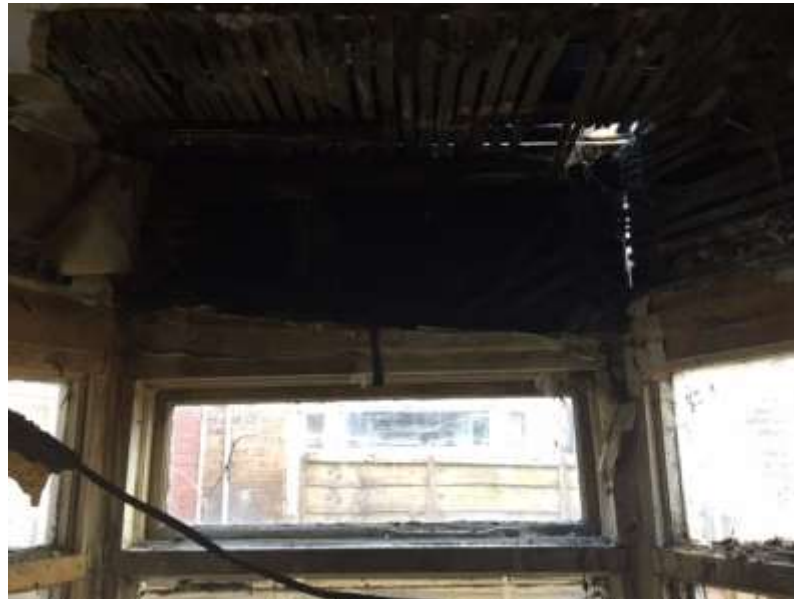
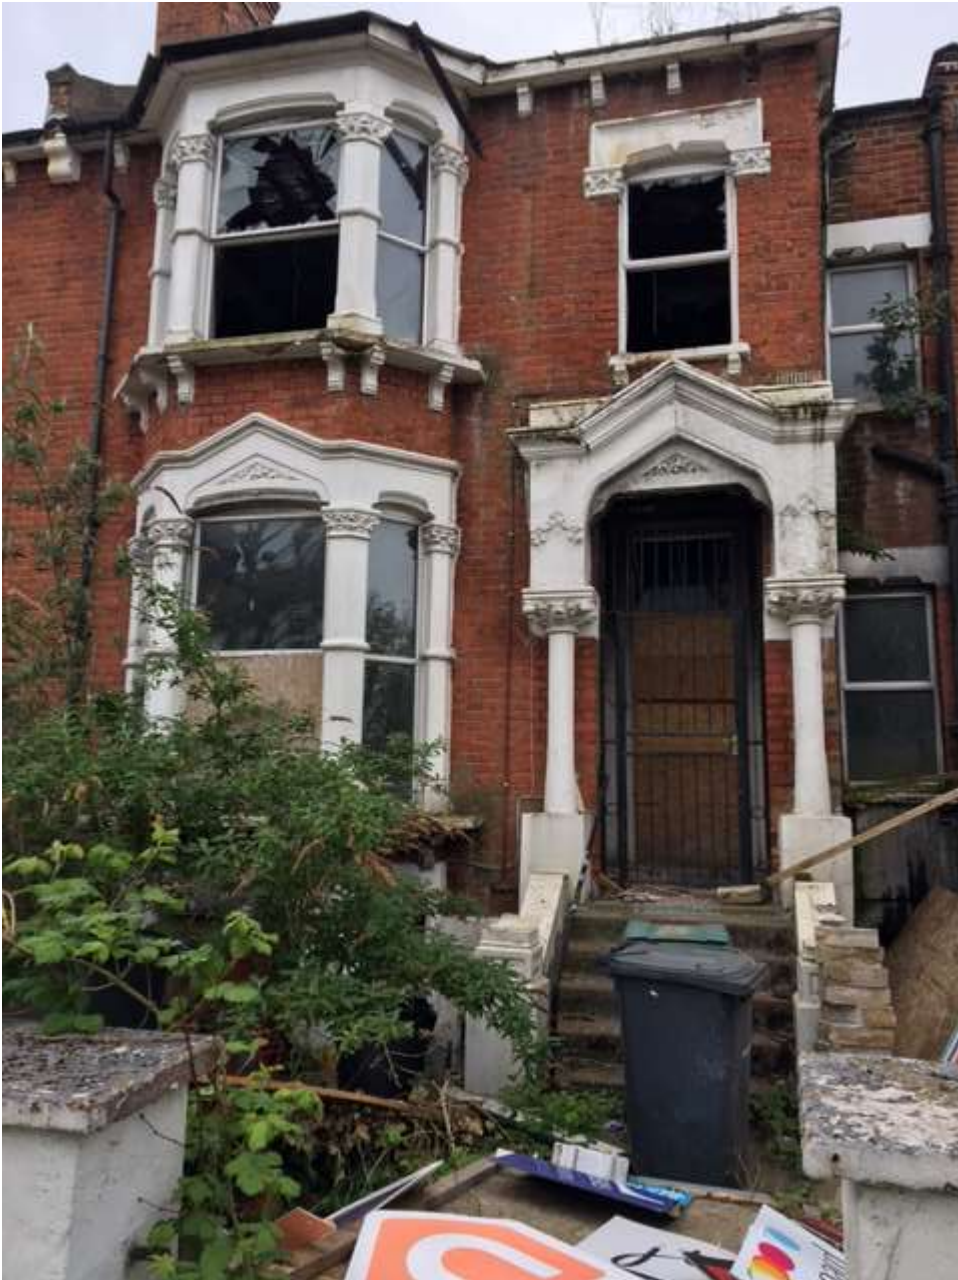
27 Elsdon Road N17

This house has been empty for the last four years since the tenant (who was a hoarder) was moved into alternative accommodation. The company who own it have failed to renovate and bring it back into use and to date there is still have no timeframe for doing any work. It has become a magnet for ASB and criminal activity.
