# Section 19 Flood Investigation Report

## Wood Green

### London Borough of Haringey

M01600-13\_DG01 | January 2022

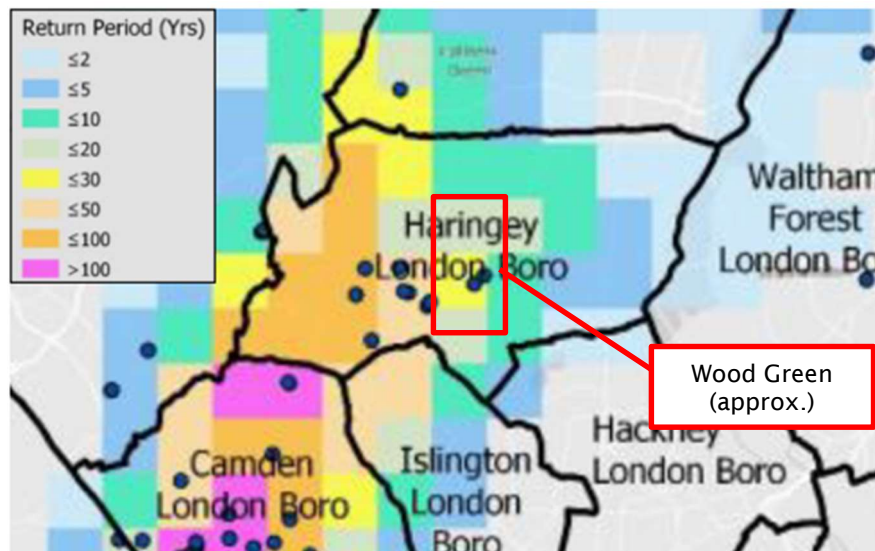
The relatively low rainfall recorded above is not consistent with the flood reports and anecdotal evidence provided from the area. The Hornsey gauges were blocked on retrieval of data and the recordings conflict with the Thames Water analysis of the event, which was presented at a recent workshop related to the floods<sup>4</sup>, and indicated that the district received rainfall return periods ranging from a <10 year to a <30 year event. The areas in which the gauges are located in Brent (Borough) and Wanstead (London Borough of Redbridge) did not experience the same intensity of rainfall experienced elsewhere, which concurs with the relatively low estimated rainfall return period derived from the rain gauge data for these locations.

**Figure 4-3 Rainfall Return Period and Report Flooding Incidents, 12<sup>th</sup> July 2021 (RaRa data using FEH99).**

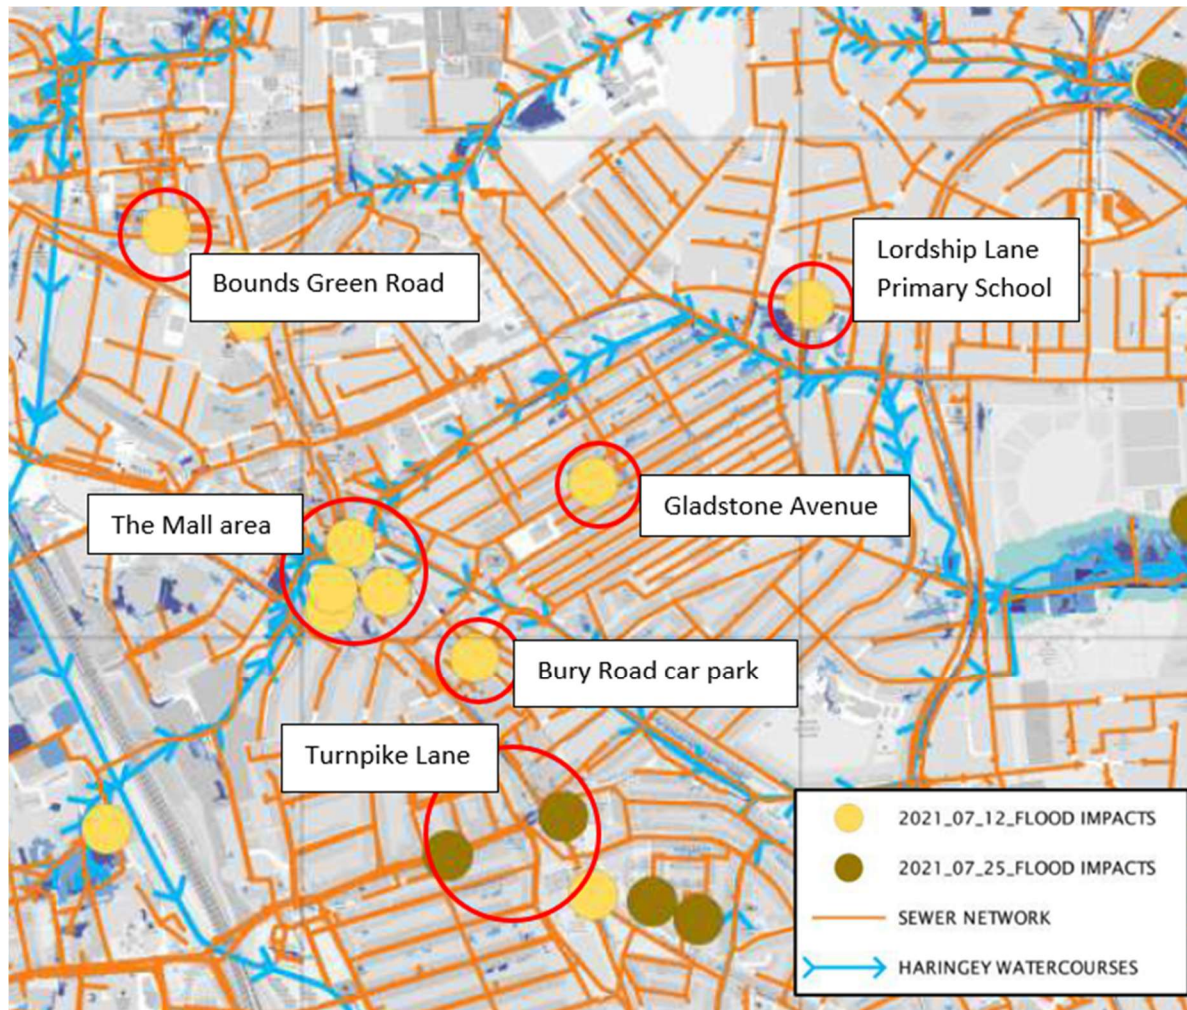
Figure 5-1 presents an overlay of flood reports from Haringey Council's Reported Flooding Impacts Mapping and highlights the areas of interest where an increased number of flood incidents were reported. Note that screened out locations also appear in this figure.

Figure 5-1 Recorded flood impacts and areas of interest in Wood Green, 12th July 2021

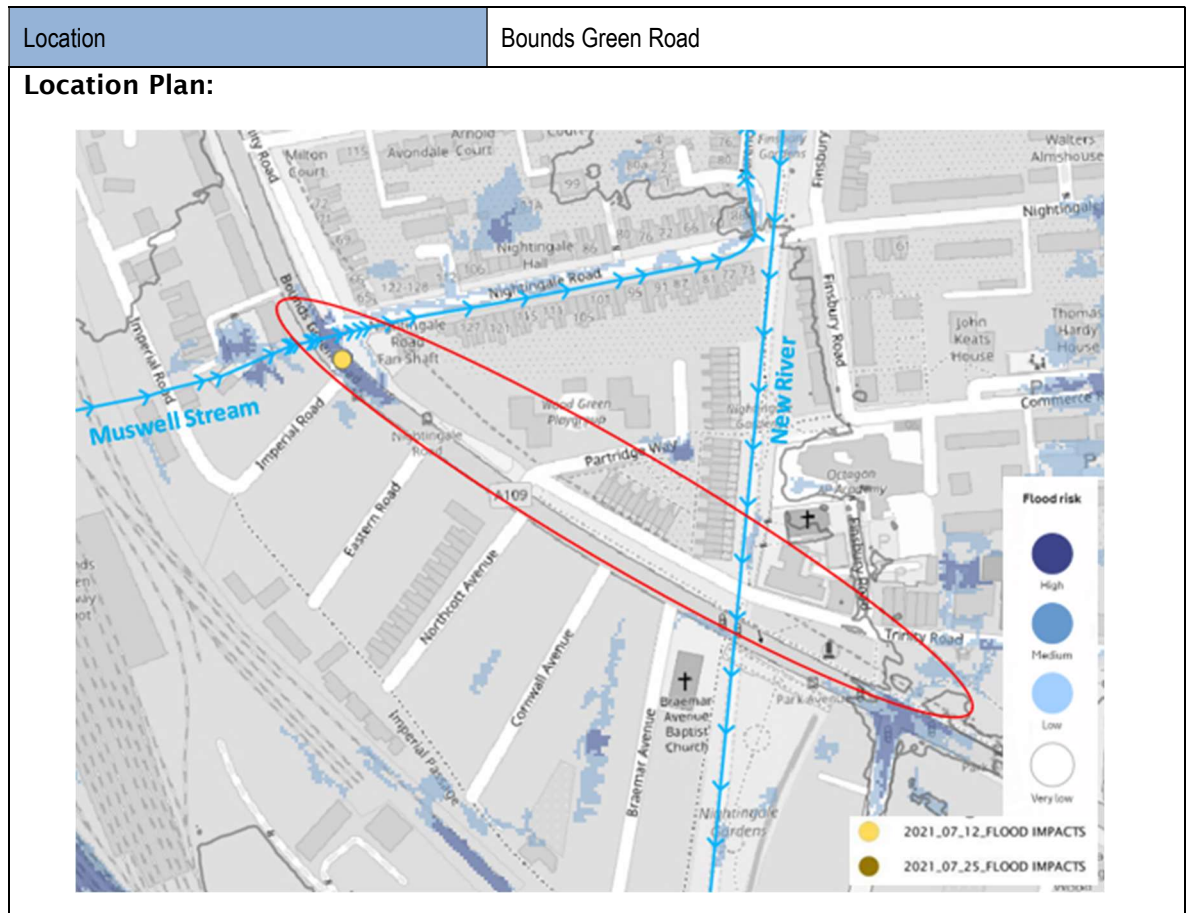
Figure 5-6 Site Location

Bounds Green Road generally falls from the Bowes Park railway overpass (circa 45mAOD) to its junction with High Road (32mAOD). There is a topographical low spot at its junction with Park Avenue. The EA maps (Figure 5-6) show two areas of high surface water risk along this section of Bounds Green Road; the junction with Park Avenue and junction with Nightingale Road. Bounds Green Road is a local distributor road with an average width of 12.5m in the area of interest.

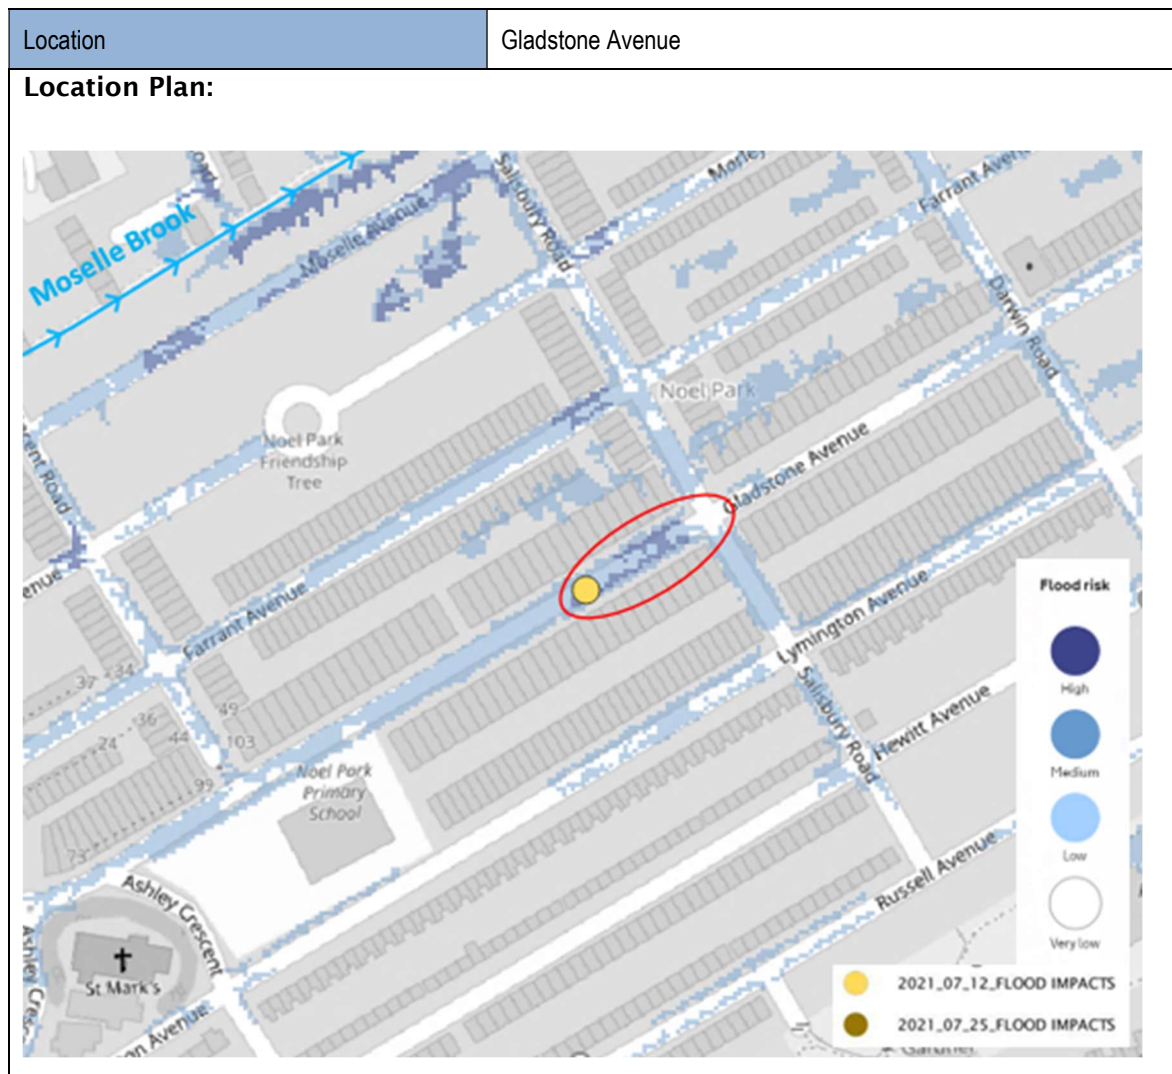
Figure 5-10 Site Location

Gladstone Avenue is a residential street which falls gently to the northeast between approximate elevations of 18mAOD and 17mAOD. The street comprises a series of speed humps along its length, and the junction with Salisbury Road is a raised table. This topography corresponds with the surface water flood risk map shown in Figure 5-10, in which it is suggested that surface water accumulates near the junction of the two carriageways.
