Section 19 Flood Investigation Report South Tottenham, London Borough of Haringey

M01600-15_DG01 | January 2022

DOCUMENT FILENAME	M01600-15_Dg01 Section 19 Investigation Rev 3
DOCUMENT REFERENCE	M01600-15_DG01
TITLE	Section 19 Flood Investigation Report
CLIENT	Haringey Council
CLIENT CONTACT	Pankit Shah
PROJECT MANAGER	Anthony McCloy
AUTHOR(S)	Andy Hughes
BRANCH	BELFAST Mossley Mill, Lower Ground (West), Carnmoney Road North, Newtownabbey BT36 5QA T: +44 (0) 28 9084 8694 W: <u>www.mccloyconsulting.com</u>

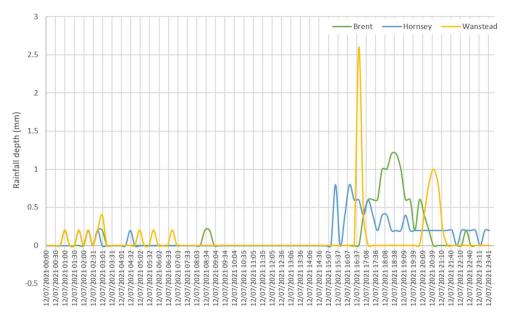
The most significant rain was recorded at Brent Reservoir between 17:00pm and 19:00pm, which recorded 7.6 mm of rainfall within this period. This rainfall is estimated as 1 in <2 year return rainfall event based on comparison of data obtained from the Flood Estimation Handbook. A total of 11.6mm was recorded for the whole day, with 10.2 mm of this falling over 3.5 hours. The rain gauge at Wanstead recorded 8mm over 24 hours, and the gauge and check gauge at Hornsey gave unreliable readings on the day due to apparatus blockages.

Figure 4-2 Rain gauge data, 12th July 2021

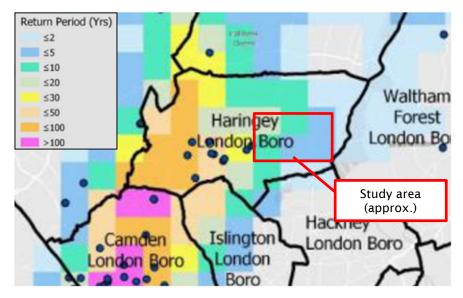
The relatively low rainfall recorded above is not consistent with the flood reports and anecdotal evidence provided from the area. The Hornsey gauges were blocked on retrieval of data and the recordings conflict with the Thames Water analysis of the rainfall event, which was presented at a recent workshop related to the floods⁶, and indicated that the district received rainfall return periods ranging from a <5 year to a <20 year rainfall event. The areas in which the gauges are located in Brent (Borough) and Wanstead (London Borough of Redbridge) did not experience the same intensity of rainfall experienced elsewhere, which concurs with the relatively low estimated rainfall return period derived from the rain gauge data for these locations.

Figure 4-3 Rainfall Return Period and Report Flooding Incidents, 12th July 2021 (RaRa data using FEH99).

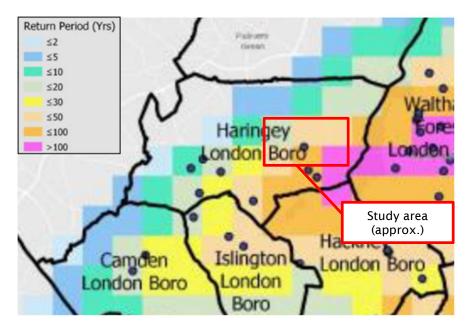
The Thames Water workshop data indicated that the district received rainfall return periods ranging from a <20 year to a <100 year rainfall event.

Figure 4-5 Rainfall Return Period and Report Flooding Incidents, 12th July 2021 (RARA data using FEH99).

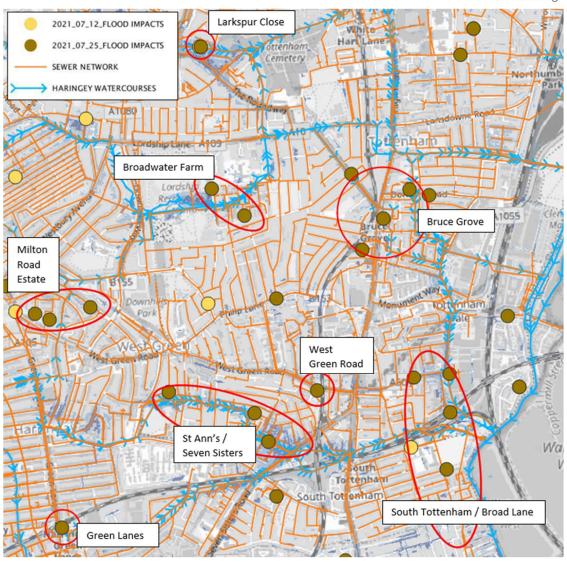
Figure 5-1 presents an overlay of flood reports from Haringey Council's Reported Flooding Impacts Mapping and highlights the areas of interest where an increased number of flood incidents were reported. Note that screened out locations also appear in this figure.

Figure 5-1 Recorded flood impacts and areas of interest in South Tottenham
