WOOD GREEN DRINKING FOUNTAIN

HIGH ROAD

LONDON N22

Condition survey and conservation assessment

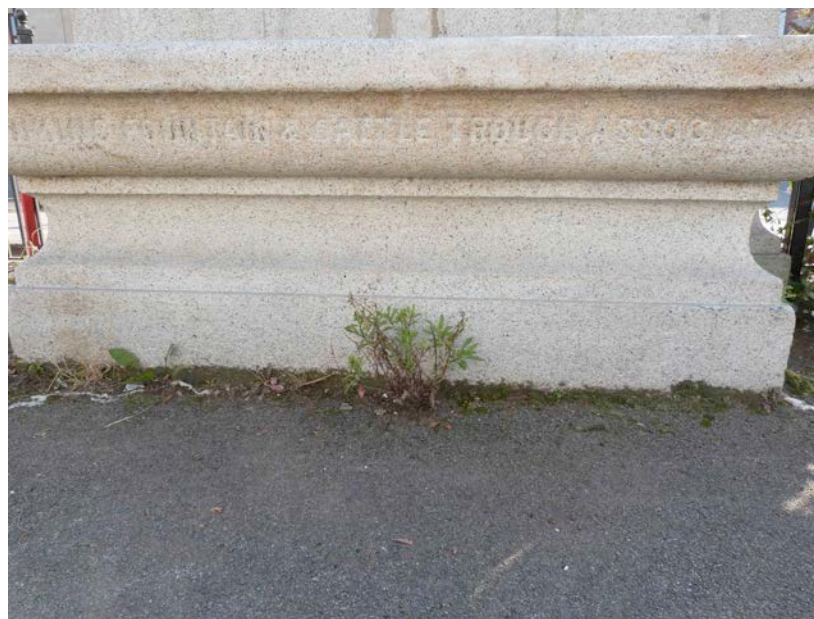
Fig 5: detail of base of cattle trough with inscription

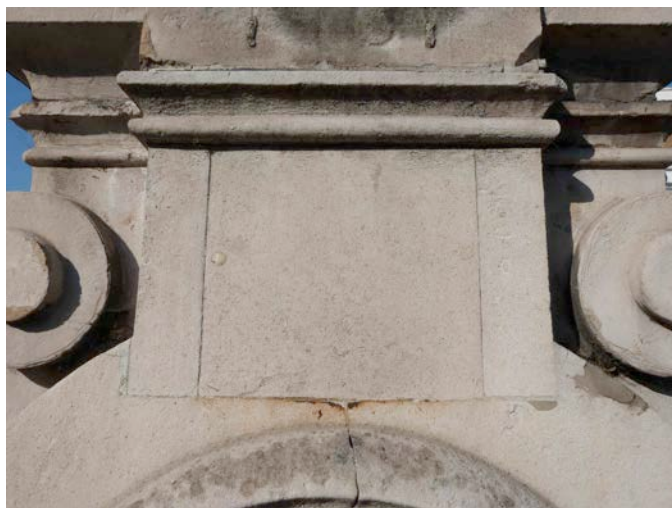
The arch on the east side is a plain moulding with a plain panel above; all of these stones are superimposed onto the main stone with a vertical joint parallel to the face. The cornice above is also a separate stone. The plain panel consists of three stones with very fine joints between them. The central stone (Fig 6) has a metal fixing (hidden by mortar) on each side; this panel was designed to be removed and to provide access to the internal water mechanism.

Fig 6: detail of east side showing removable panel

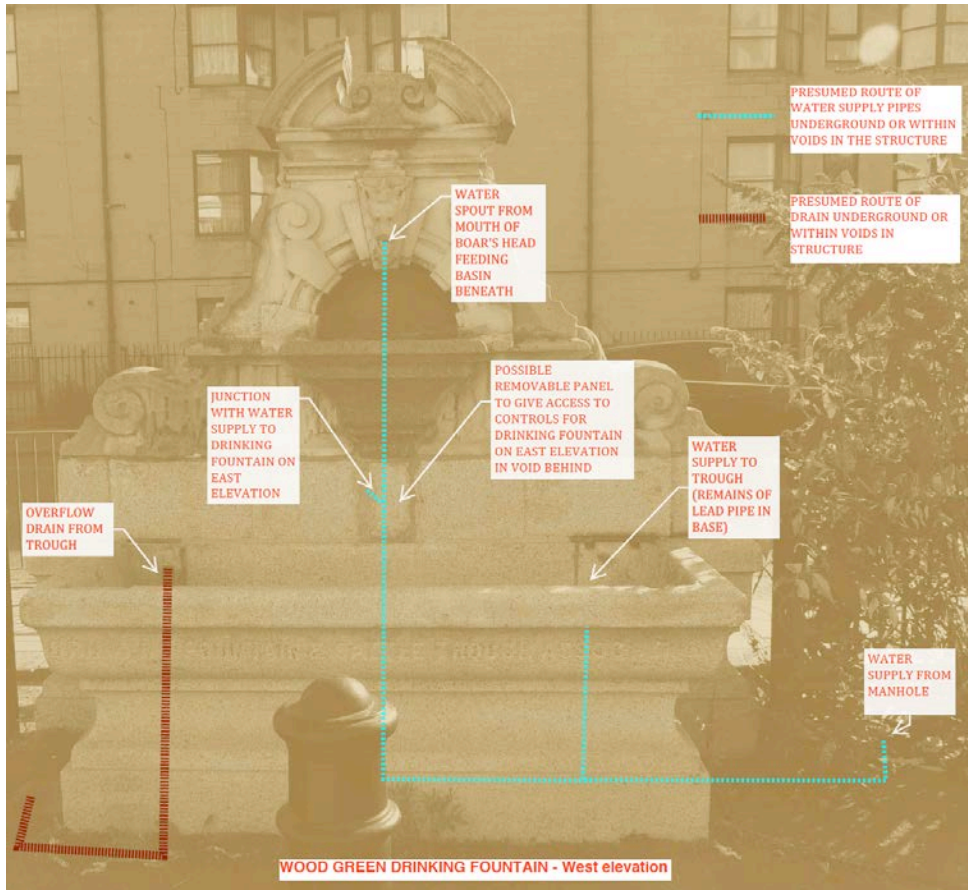
Fig 37: schematic drawing showing the water supply and drainage (west side)

There appear to be only two drains in the structure. One is the corroded iron overflow drain in the north end of the large trough. This may however be a later addition although it is likely that there was some sort of drain in this location. The other drain is in the back of the bowl on the east elevation. Both these drains seem to lead to the north end where there is a concrete cover. However this was not confirmed during the inspection. Figs 37 and 38 show a schematic version of what is thought to have been the arrangement of the plumbing.

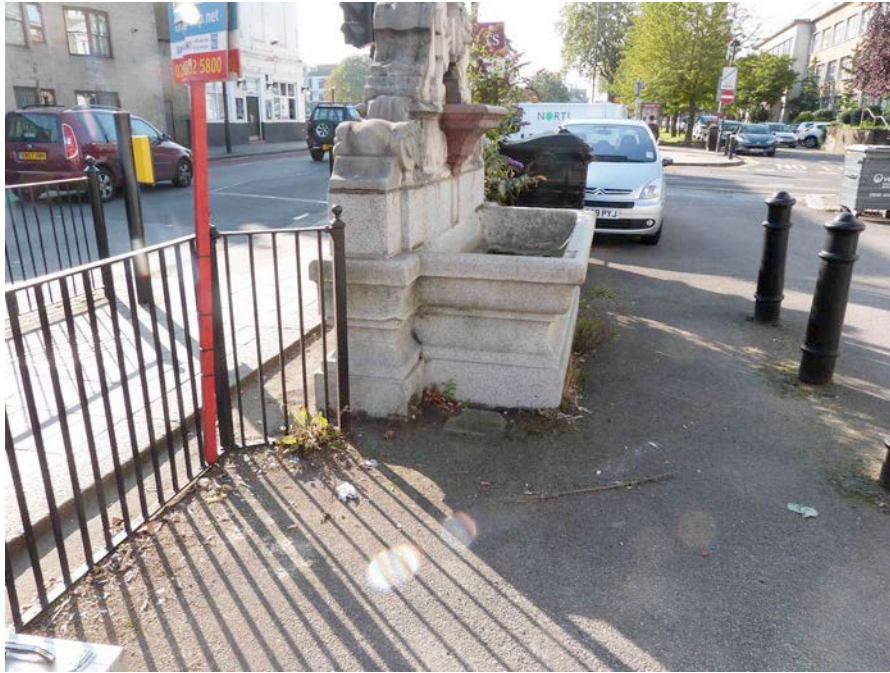
Fig 39: view of drinking fountain from north-west showing drain cover next to the trough

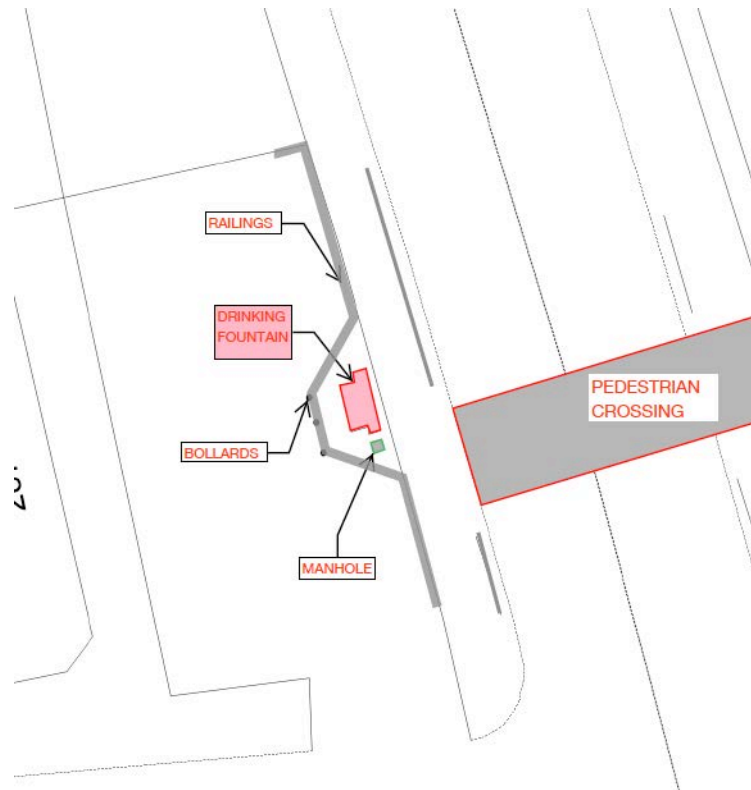
Fig 40: possible proposed re-routing of railings

A major part of the significance of the fountain is its location in front of the (now closed) public house ("The Fishmonger's Arms"). The removal of the fountain to another location would be practically difficult and expensive but also would sever the important link between the fountain and its *raison d'être*. There is however some benefit to be had by changing the setting so as to encourage the public to be aware of, and engage with, the fountain. This might best be accomplished by changing the layout of the railings so that they incorporated the current bollards (see Fig 40). Such a proposal would require input from the local authority. Whilst it would have the advantage of bringing the fountain more into the public domain, it might also encourage more misuse of the cattle trough.
