# DESIGN & ACCESS REPORT

## St Ann's Library Hall Project - Cissbury Road London N15

### 1.0 Introduction

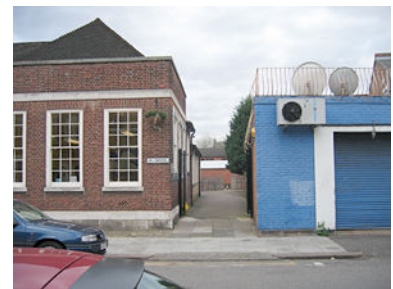
Cissbury Road Branch Library is located in a predominantly two-storey terrace residential road, with retail units on the corner of St Ann's Road.

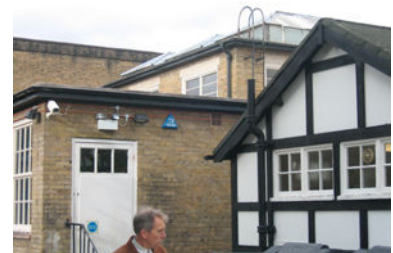
The existing library hall is not visible from the street, being sheltered by the main library frontage. The hall is a single storey free standing building set at the rear of the Library with planted and hard landscaped space on three sides and a narrow alley between it and the library on the forth side.

The rear garden walls and fence of the adjoining two-storey terrace housing and a single storey workshop unit form the boundary surrounding the site.

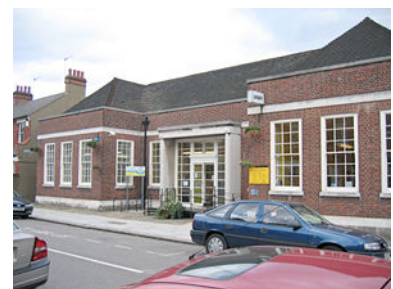
The hall consists of a timber structural frame with lightweight panel in fill. The pitched roof is of bituminous felt finish supported on timber roof trusses. The fenestration comprises timber casement windows, clerestory windows and rooflights.

The main Library consists of a single storey symmetrical façade with pitched roof fronting Cissbury Road. The library is also planned symmetrically comprising a double-height central reading space, with two wings of supporting accommodation behind a constant parapet line. The materials on the main elevation are warm red brick walls on a stone base and tiled roof, with stock bricks to the flank and rear walls and asphalt flat roofs. Windows are generally are a mixture of metal and timber.

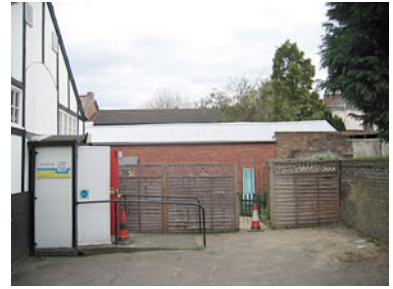
The hall already is a well used local amenity, being served by good public transport links and a network of pedestrian routes. Public access to the hall is via gated passages on both flanks of the main library fronting onto Cissbury Road, with the wider approach to the rear being on the S.W. side nearest to the St Ann's Road junction. A dropped kerb from the road allows limited vehicular access into the rear of the site for delivery and service vans.

A rear exit from the library also leads to hall and the adjacent side passages.

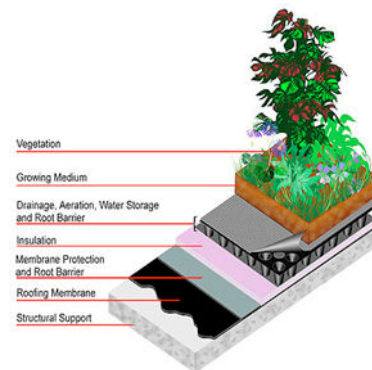
The main envelope is proposed as facing bricks to match the warm red and yellow stock brick of the existing library, alternating in horizontal bands every fourth course.

Windows and screens are proposed as high performance aluminium assemblies with gunmetal grey anodised finish.

The finish of the folded roof profile over the main hall is proposed as a single ply membrane, self-coloured, mid grey in keeping with the slate roofs of the surrounding dwellings. The fascias are of matching powder coated metal pressings.

The flat roofs to the side wings are proposed as “extensive green roofs” finished in self-maintaining sedums, to provide a living, colourful and sustainable finish to benefit the surrounding outlook.

Internal materials comprise a self finished perforated maple veneered plywood soffit to the main space, proposed to provide acoustic absorption and visual warmth to the space.
