Sub Area 1: The Core Area: Crouch End Town Centre

4. SPATIAL AND CHARACTER ANALYSIS

Sub Area 1. The Core Area: Crouch End Town Centre

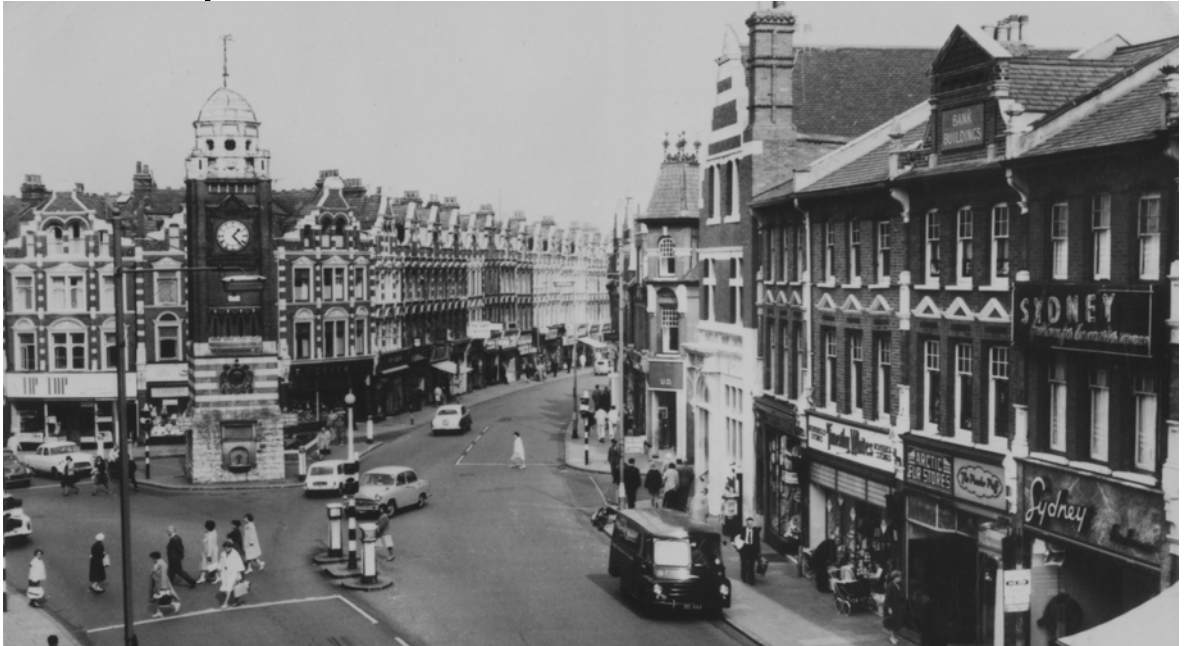
- 4.4 The Broadway makes up the key section of the primary retail frontage of the town centre. Because of its history as one of the principal routes between London and the north The Broadway became a wide thoroughfare long before it was lined with the existing development. The junction at the northern end is dominated by the Grade II listed Clock Tower that stands within a traffic island at a major crossing point for pedestrians negotiating the busy vehicular traffic passing through The Broadway. In views north along The Broadway it appears as an important and distinctive landmark against the sharply curved backdrop of Topsfield Parade and dominates views south along Tottenham Lane and Park Road. Unfortunately, the volume of traffic and the clutter associated with traffic management detract from the high quality townscape character of this area.

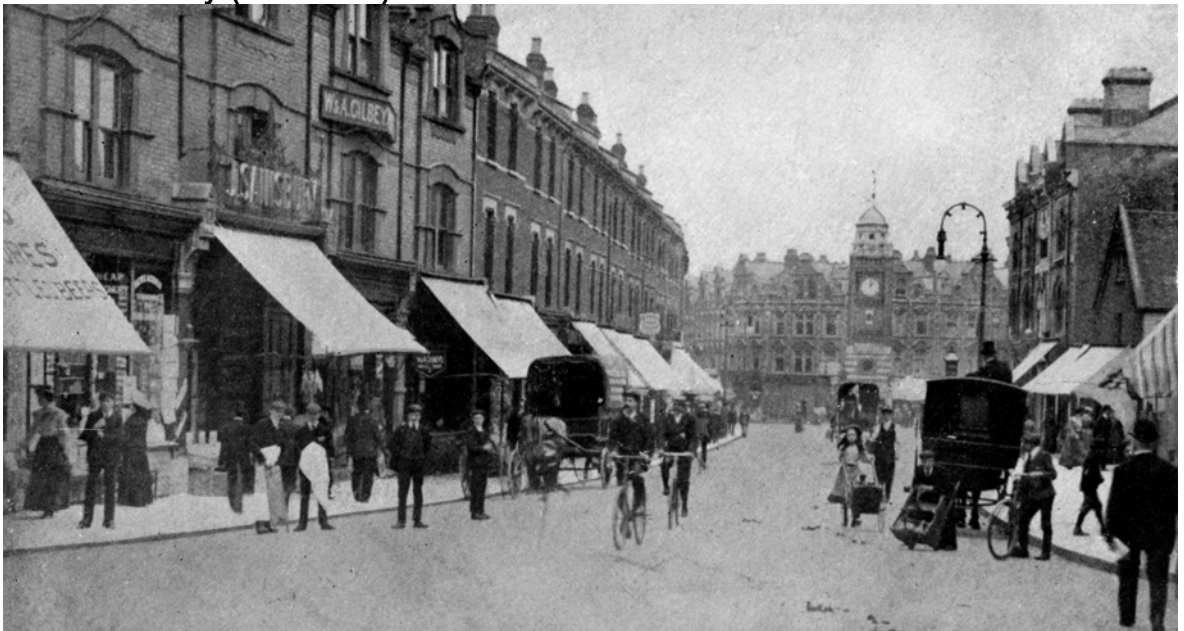
The Broadway (west side)

- 4.7 The west side of The Broadway, from Coleridge Road in the south to Middle Lane in the north, is lined with a collection of terrace properties of varied ages and architectural quality. At the southern end, No. 1 is a three storey late 19th Century yellow stock brick corner building with an attic storey with cambered headed

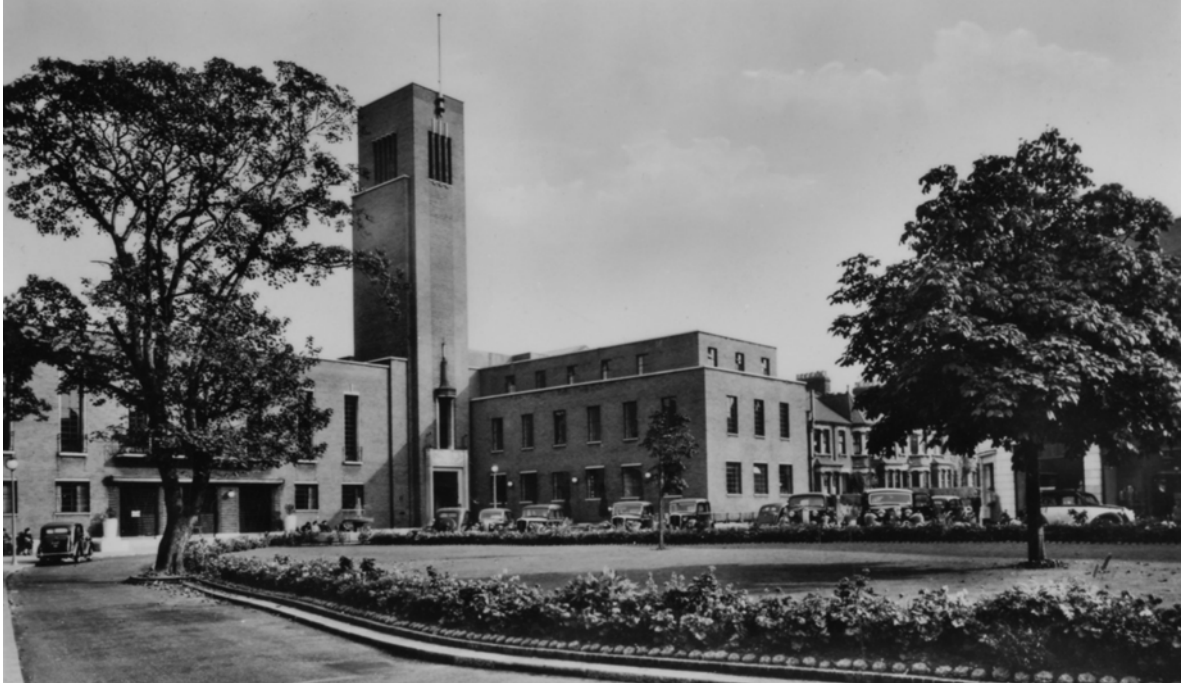
- 4.20 The public square was originally formed to set back the Town Hall from the street frontage to give it some dignity in a formal setting and to provide parking spaces. Although the parking spaces were later removed the space currently does little to enhance the setting of the surrounding listed buildings because its layout makes it difficult to use as a unified space. It is poorly subdivided by its different surface treatments and is difficult to move across because of physical barriers, including part of the paved area in front of No. 26 The Broadway, on the northern side of the square, currently being taken over as an outside café area. The pedestrian pavements in front of the shops are at the same level as the pavements on The Broadway and retain their original large interlocking artificial stone slabs and granite kerbstones. The kerbstones continue around the pavements in front of the former Town Hall, but this section has uneven patched and broken square concrete paving and contains 18 cast iron bollards. The large space in front of the Town Hall accessed from Hatherley Gardens is at road level, surfaced with tarmac as it was designed as the vehicular access and drop off point for the Town Hall and Public Assembly Hall. It has a turning circle within which is a raised roughly oval area of granite setts and an elegant Deco style stone fountain with a circular basin raised on a fluted base in a circular stone bowl with fluted bands at regular intervals around its sides, sadly no longer with playing water. The reinstatement the sound and appearance of flowing water to the fountain would add a soothing feature that would greatly enhance the character of this public

square. The area nearest to The Broadway is laid out as a lawn with small flower beds and hooped metal railings restricting pedestrian movement. Behind the bus stop on The Broadway is a small tree with a plaque inscribed "This tree was planted in December 1998 by Hornsey & Wood Green Group of Amnesty International to commemorate the 50th Anniversary of the UNIVERSAL DECLARATION OF HUMAN RIGHTS". The quality of the character of this important quiet resting space within the otherwise bustling Broadway is greatly enhanced by the large attractive mature trees within the lawn and in the adjoining raised areas of granite setts. Although fairly well maintained and regularly stocked with bedding plants, the quality of the design and layout of this important meeting space in the heart of Crouch End is in need of further improvement to create a more useful and attractive space in front of the former civic buildings. Encouragement will be given to uses that will draw the vitality of The Broadway back into the site, reinventing the open area as a public piazza, a lively and animated space with high quality landscape.

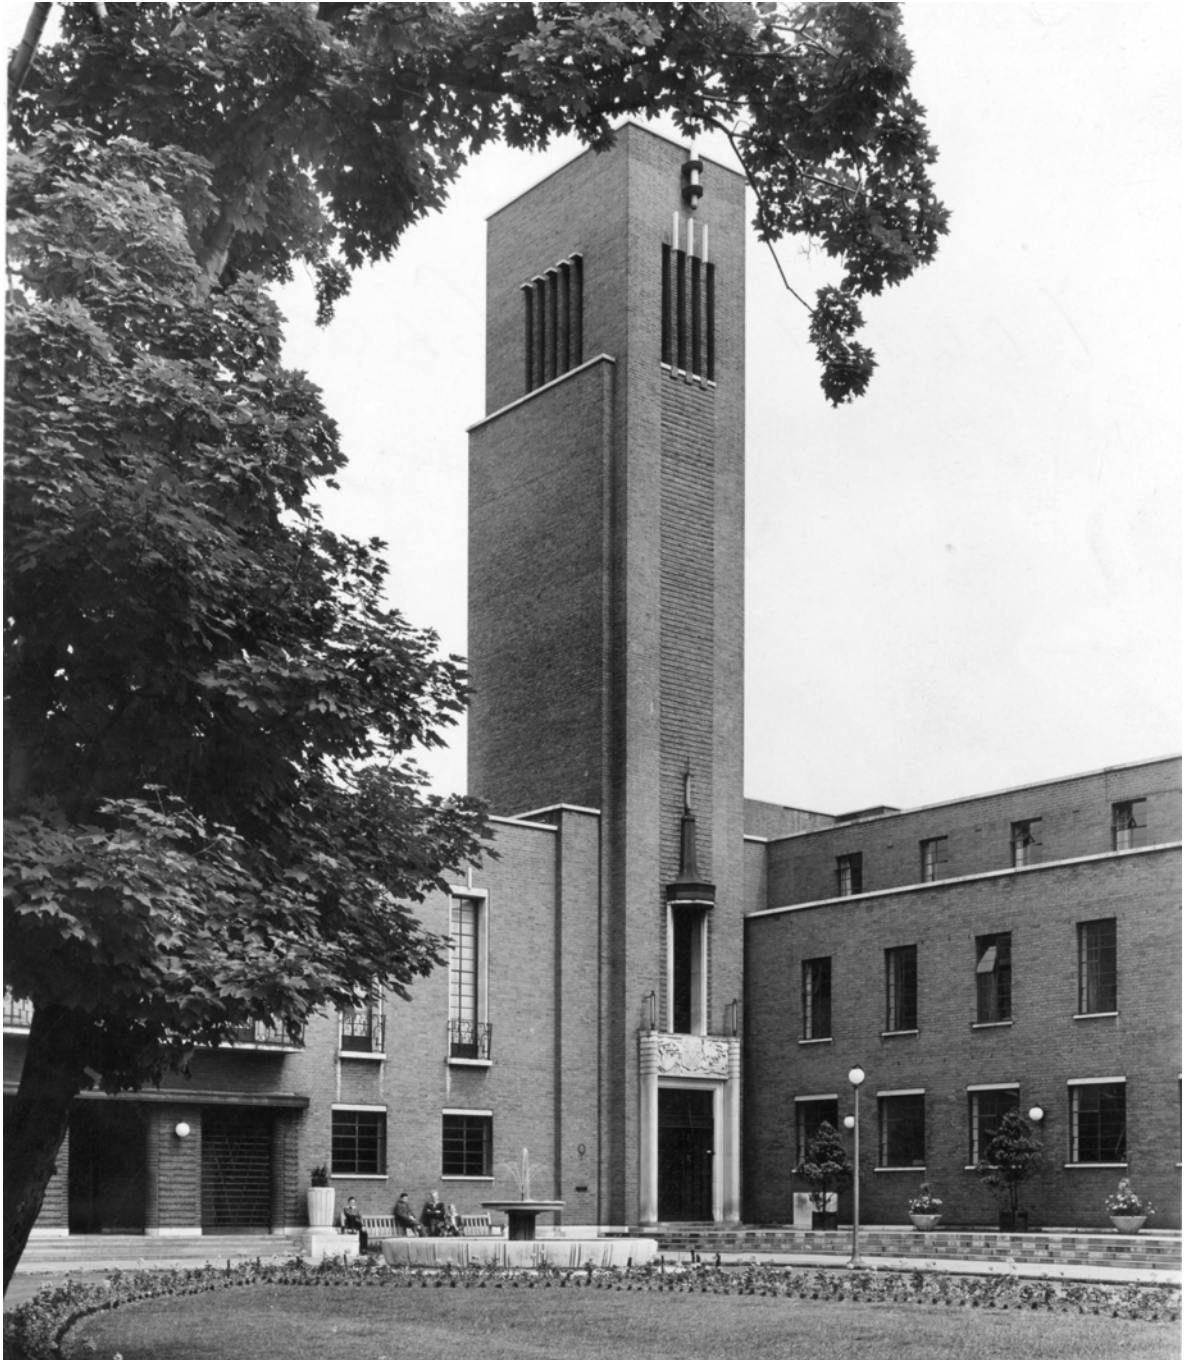
- 4.21 The former Hornsey Town Hall and adjoining Public Assembly Hall form the boldly massed asymmetrical architectural centrepiece along the eastern edge of the public square, with its tall rectangular tower and flagpole acting as a local landmark visible from many parts of the conservation area. This Grade II* listed building was designed by the gold medal winning RIBA architect Reginald Harold Uren and built between 1934-5. It is an important example of Town Hall architecture inspired by the internationally influential Hilversum Town Hall of 1928-30 by W M Dudok, but unfortunately is currently considered to be surplus to requirements and largely unused. The building is avowedly 'Modern' with Art Deco style details and is made from hand made beige/pinkish brick with stone dressings, stone coped parapets and flat roofs. The main frontage on the west side facing the public square is of two tall storeys equivalent in height to the neighbouring three storey buildings with tall metal casement windows with stone architraves and the tower in the south eastern L shaped corner of the building. The forward projecting right side section has a set back attic floor.

- 4.22 The Public Assembly Hall is clearly distinguishable by the main ground floor triple entrance doors set within a wide rusticated brick surround below a first floor ceremonial balcony and large elongated first floor foyer windows that give it a horizontal emphasis. Its entrance doors and balcony are all fitted with bronze bars, guards and grilles in Art Deco style patterns. The Council Offices have a more decorative large entrance door at the base of the staircase tower that has wide stone architraves and a lintel containing a carved low relief sculpture by Arthur J J Ayers incorporating the Hornsey Metropolitan Borough coat of arms below a long window with a copper grille and tall bronze hood. The upper part of the tower is blank with horizontal raised brick strips except for the top stage that has slit windows with stone hoods.

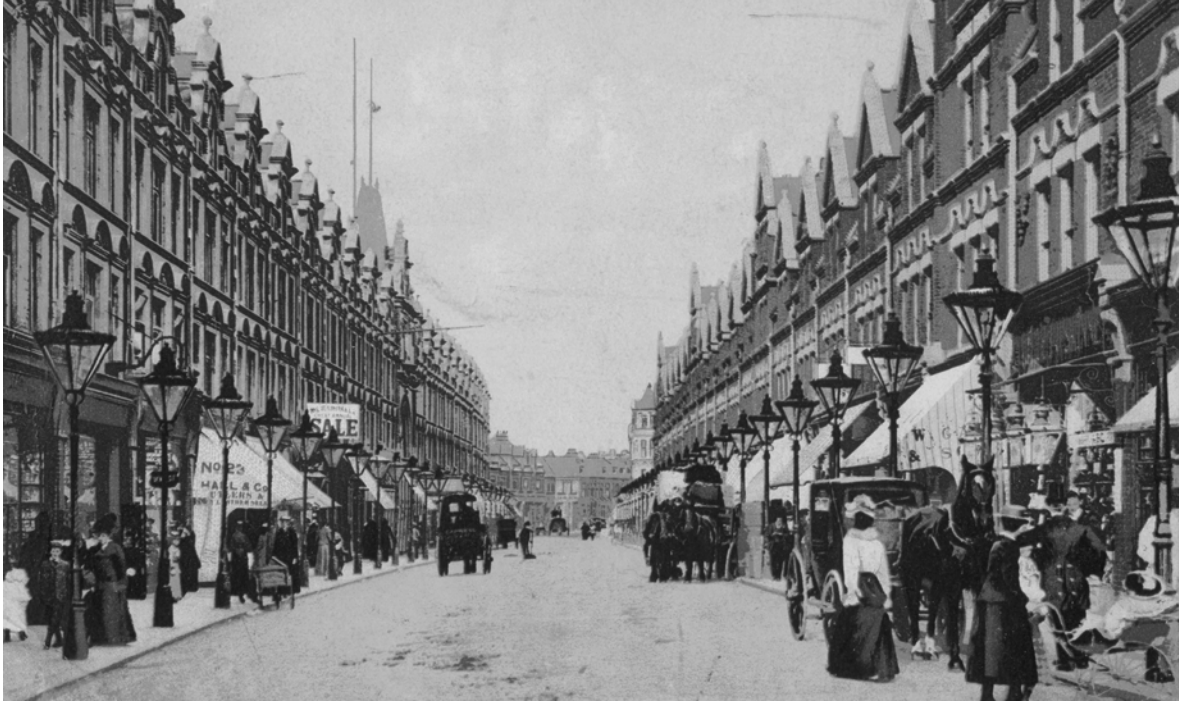
- 4.36 Tottenham Lane forms the north-east approach to The Broadway. It is a shopping street with three storey terraces of red brick and stone elevations and repeated roof level gables that give a substantially consistent appearance along both sides, further enhanced by their pattern of vertically proportioned fenestration on the upper floors and ground floor shop units. The narrowness of the street, height of the buildings and continuous frontage gives it considerable sense of enclosure, with the clock tower providing a focus for the view looking south-west. Broadway Parade along the south-east side extends the adjoining terraces on the east side of the Broadway, with the highly decorated Grade II* listed Queen's public house as a landmark building at the junction with Elder Avenue. The turret on the corner forms a feature at roof level in views in both directions along Tottenham Lane. Topsfield Parade along the north-west side turns around the northern end of the Broadway to extend as far as Middle Lane. Unfortunately, the view north-east along Tottenham Lane out of the conservation area is closed by the uninspiring elevations of the late 20th Century YMCA building. The street is noisy with the volume of buses and lorries passing through. There are no street trees and the pedestrian pavements are clad in small uneven square paving behind retained original granite kerb stones. As in The Broadway, the original street lighting has been replaced by metal reproduction lighting columns with banners.

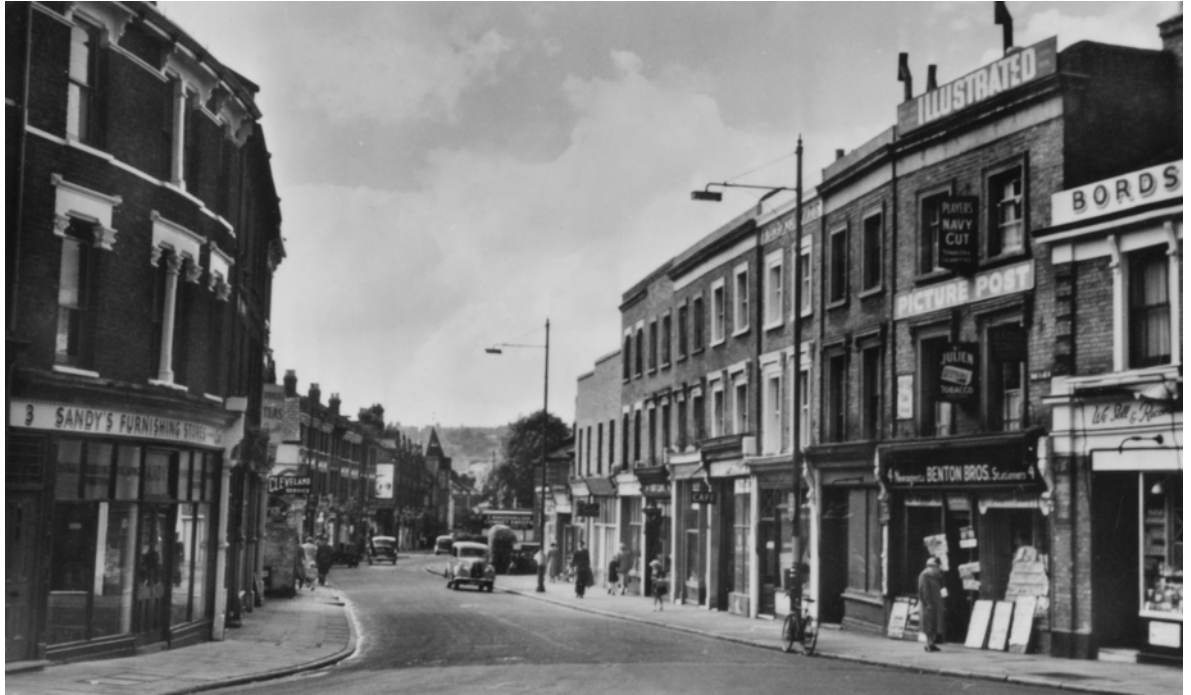
- 4.48 Park Road forms the approach to the town centre from Muswell Hill and the north-west and also has terraces with ground floor shop units, but they are secondary to those on The Broadway and Tottenham Lane. It is a very busy road with a high volume of cars and lorries, and is also a bus route. The pedestrian pavements retain their original granite kerbstones but now have small square concrete paving that is uneven and patched with brick paviours. The restricted width means that there are no street trees and the original street lighting has been replaced by inappropriately designed modern lighting columns. There is considerable lack of consistency in the style of bollards used in Park Road; there are inappropriate concrete bollards outside Nos. 11 to 19 (odd); 2 cast iron Tuscan column style bollards outside Nos. 44 & 46; and a plethora of 18 cast iron Tuscan column style bollards, 2 bell bollards around the junction with Lynton Road and Wolseley Road and 22 obelisk style bollards in the adjoining part of Lynton Road. The buildings on Park Road are more varied in height and materials than many of the other roads as a result of their development over a longer period.

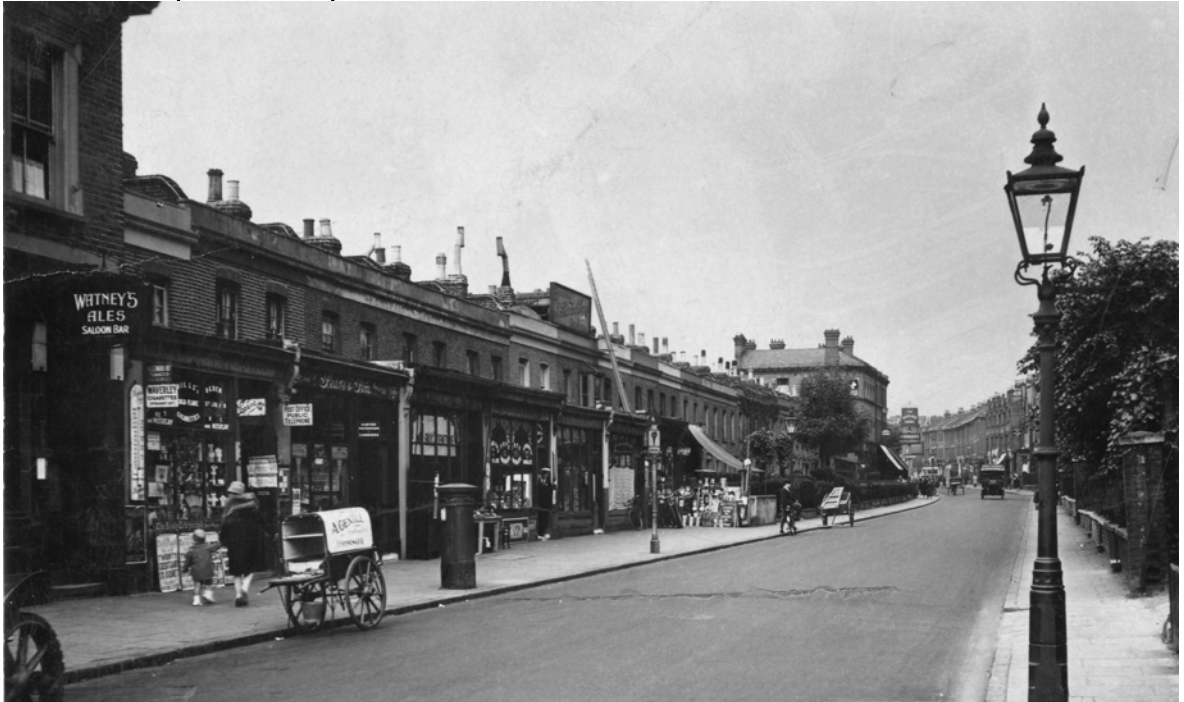
Park Road (north side)

- 4.49 No. 2, on the corner of Middle Lane, is a two storey mid 19th Century red brick building that was a corn merchant's from 1852, but is shown to have been the post office on the 1870 Ordnance Survey. It has a stucco parapet and cornice and a ground floor shopfront with stucco surround, pilasters and entablature. It has a forward projecting four window wide section fronting Middle Lane with a recessed curved corner section that contains the main entrance. The building makes a positive contribution to this part of the conservation area

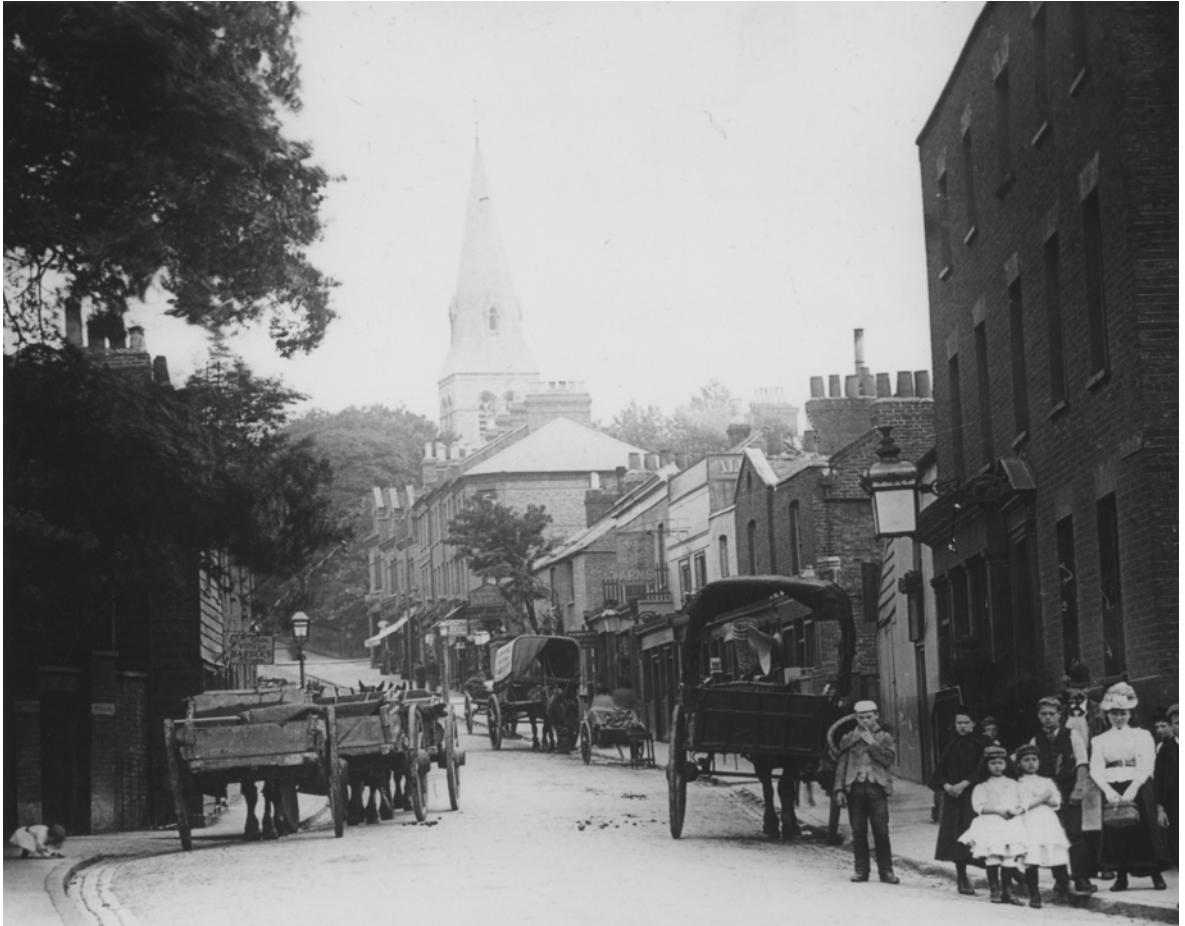
4.68 Crouch End Hill forms one of the southern approaches to the Broadway. It is a main road with a variety of buildings of differing character and appearance that step up the hill away from the Broadway either as distinctive individual structures or as stepped terraces. There are no trees within the part of Crouch End Hill within this sub area, but in contrast, views to the south up the hill are closed by many mature trees. The original granite kerbstones have been retained, but the pedestrian pavement is made up of patched and often broken small square concrete slabs that are unsuitable for this key thoroughfare within the conservation area. Original cast iron lamp standards have been replaced by reproduction Edwardian street lighting.
